The influence of microstructure of 30MnB4 steel on hydrogen-assisted cracking

Abstract

This paper analyzes the fracture behavior of zinc-coated screws made of 30MnB4 steel after proper and improper heat treatment followed by baking performed as a means of dehydrogenation.

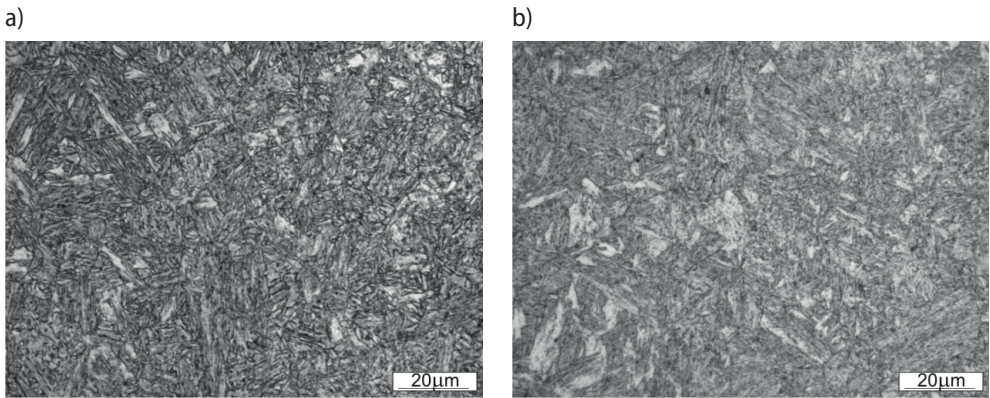
The material used in this study was a commercial low-alloy 30MnB4 steel, widely used for screw fabrication. Quenched and tempered (tempering at 410°C) screws made of this steel were electrolytically zinc-coated with an Fe/Zn12c1B layer followed by baking at 200°C for 5 h. The microstructure of the investigated screw after this process (no. 1) is shown in Figures 1 and 2. For the purpose of this work, zinc coating was performed for the quenched screw but not the tempered.

Fig. 1. Cross-sectional microstructure of screws after Process no. 1, light microscope: a) screw no. 1; b) screw no. 2; etched with 2% nital

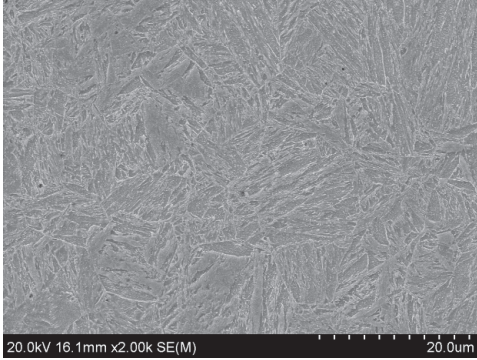
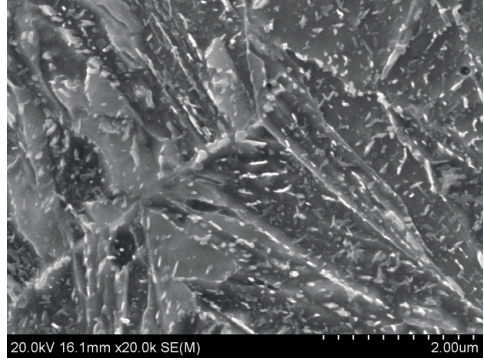
The microstructure of the screw after this process (no. 2) is shown in Figures 3–5. The morphology of the carbides in the screw after Process no. 1, its distribution, and quantity responds to the microstructure expected after quenching and tempering at 410°C (Fig. 2). The higher number of smaller carbides observed in the microstructure of the screw after Process no. 2 as compared to the screw after Process no. 1 responds to the microstructure expected after quenching and low tempering (Fig. 3).

Fig. 2. Cross-sectional microstructure of screw after Process no. 1 (screw no. 1), SEM; etched with 2% nital magn. x2000 (a) and x20000 (b)

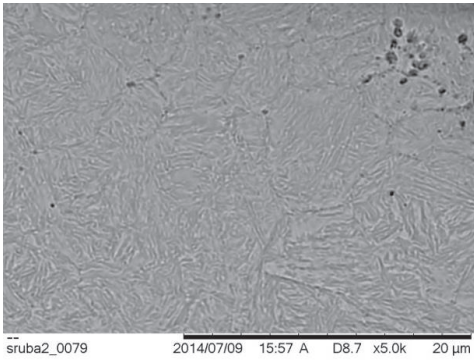
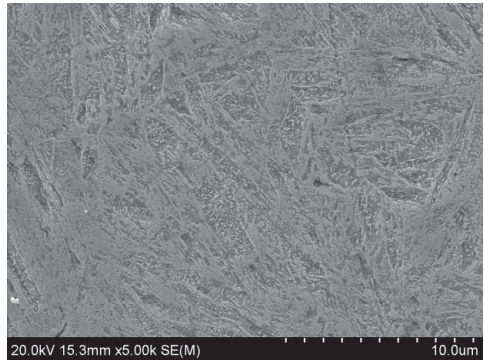
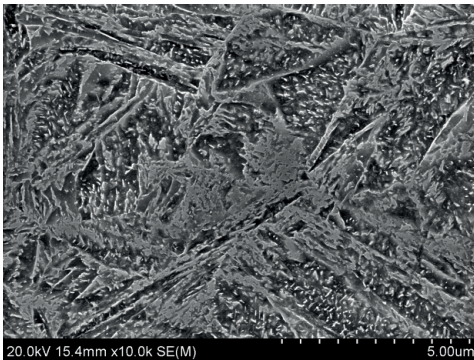
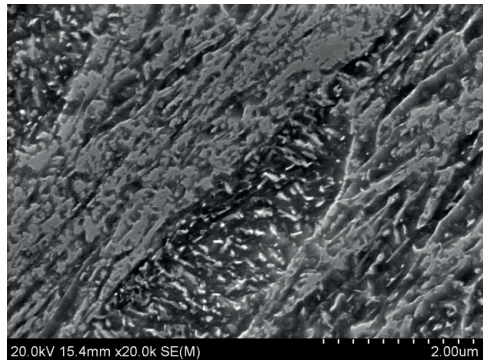
Fig. 3. Cross-sectional microstructure of screw after Process no. 2: a) subsurface below zinc layer; (b–d) area in core of screw; SEM; etched with 2% nital

1. The microstructure of the sample (screw) quenched but not tempered (Process no. 2) has a high number of carbides as compared to the sample (screw) quenched and tempered (Process no. 1). Carbides precipitated during baking at 200°C were visible on SEM images in the screw after Process no. 2,

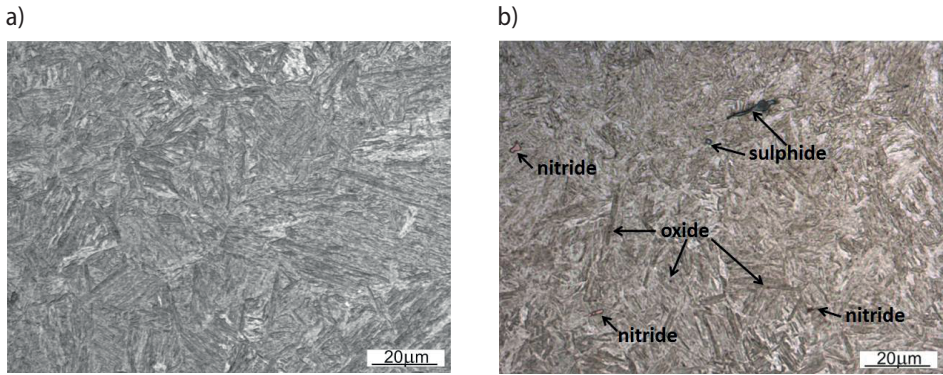
Fig. 4. Cross-sectional microstructure of screw after Process no. 2, light microscope: a) microstructure; b) non-metallic inclusions morphology; etched with 2% nital

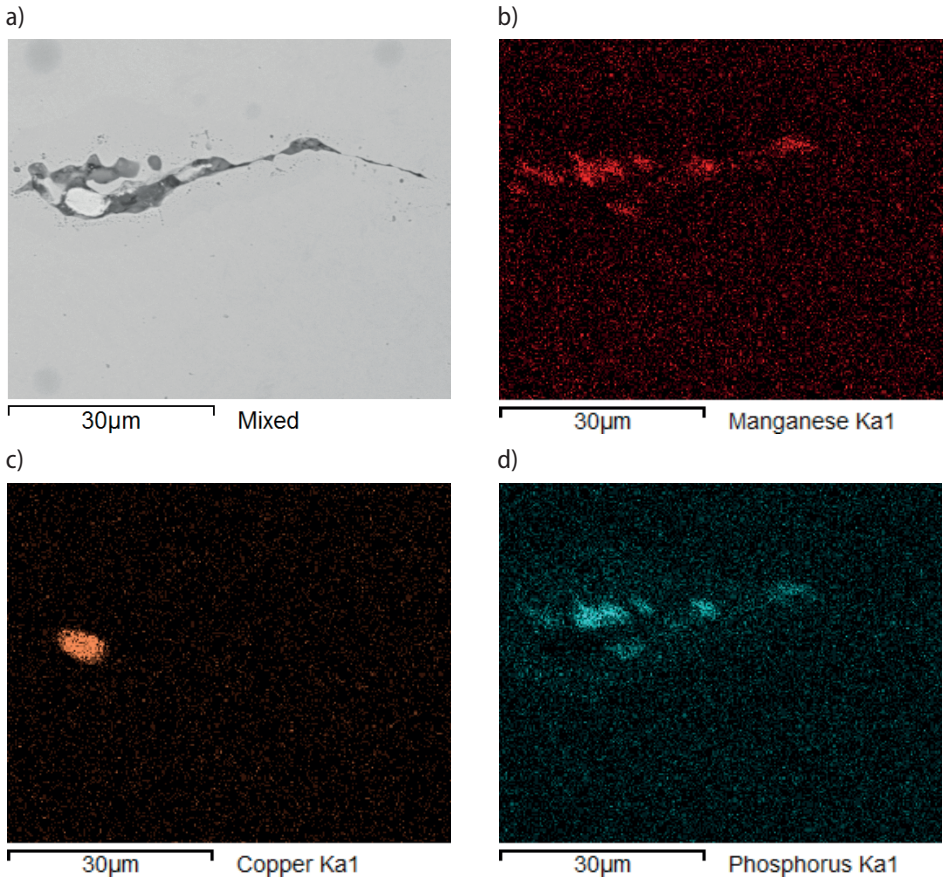
Fig. 5. EDS element map from conglomerate of non-metallic inclusions and copper in cross-section of screw after Process no. 2: area in core of screw: a) SEM; (b–d) EDS element map

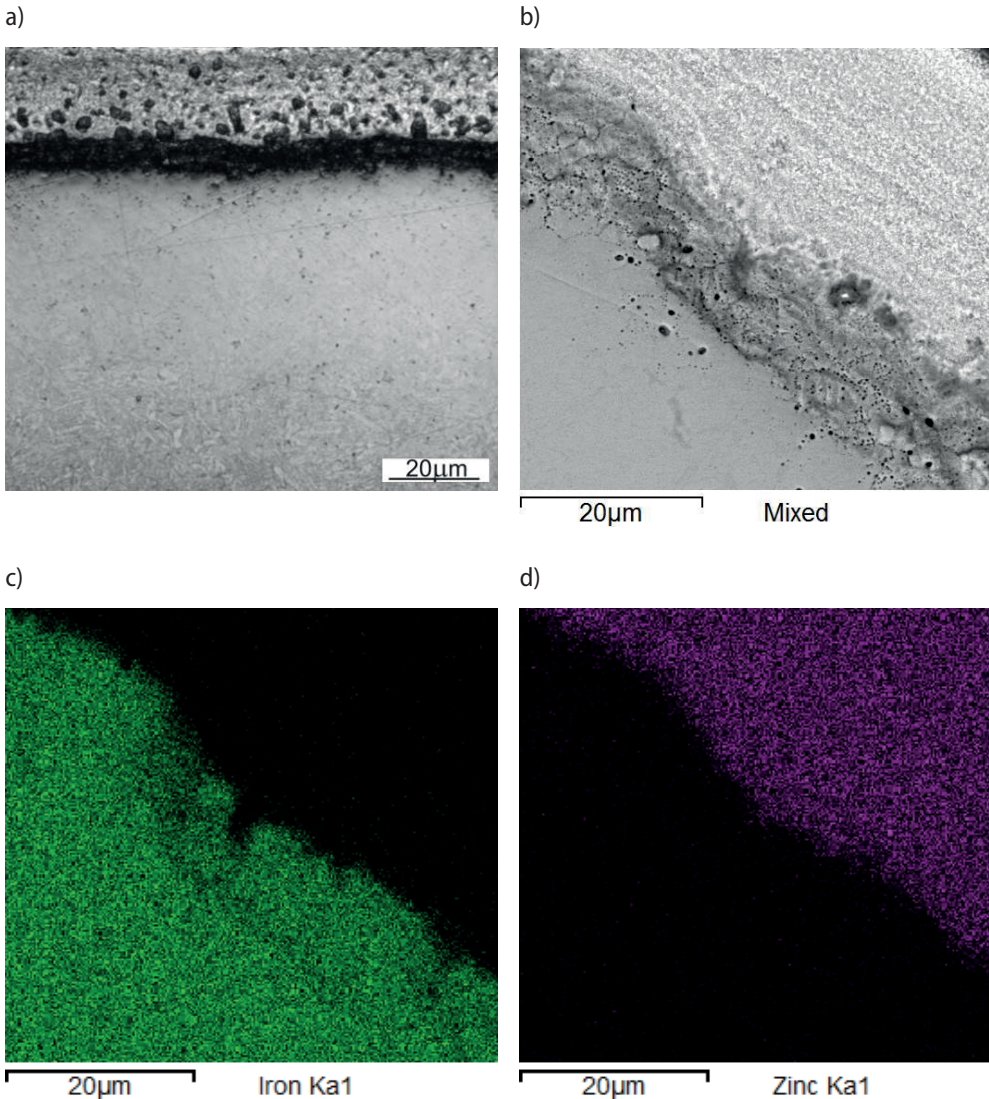
For the screw after Process no. 1, the zinc coating is uniform and proper (Fig. 6). In the case of the screw processed according to Treatment no. 2, the zinc layer is not uniform; however, numerous examples of zinc diffusion in the areas of the subsurface cracks are shown (Fig. 7).

Fig. 6. Zinc coating of screw after Process no. 1: a) light microscopy; b) SEM; (c, d) EDS element map

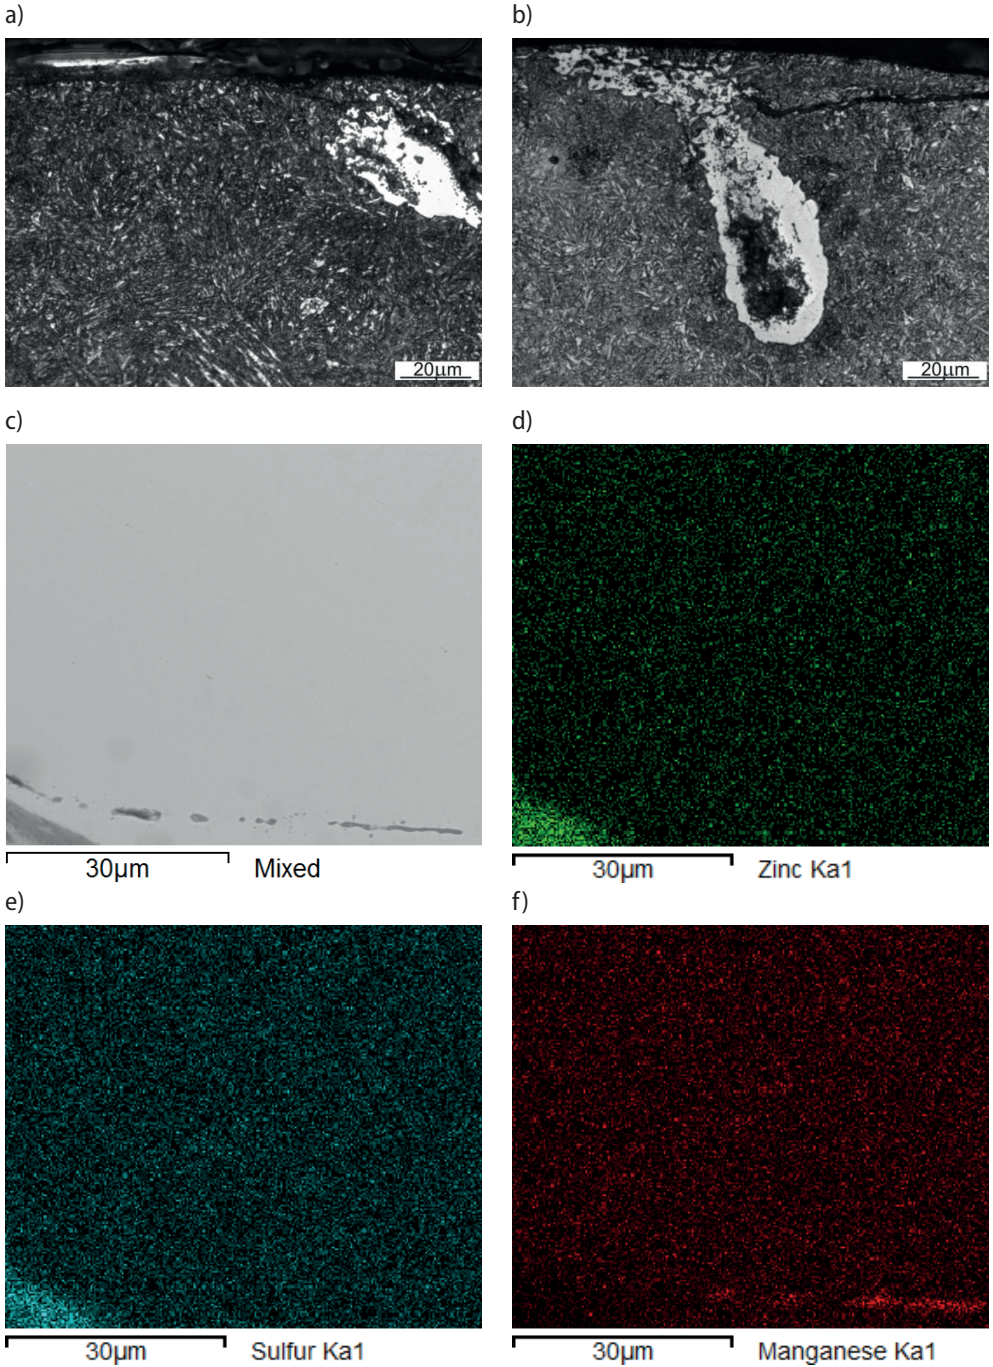
Fig. 7. Zinc coating of screw after Process no. 2: (a, b) light microscopy; c) SEM; (d–f) EDS element map

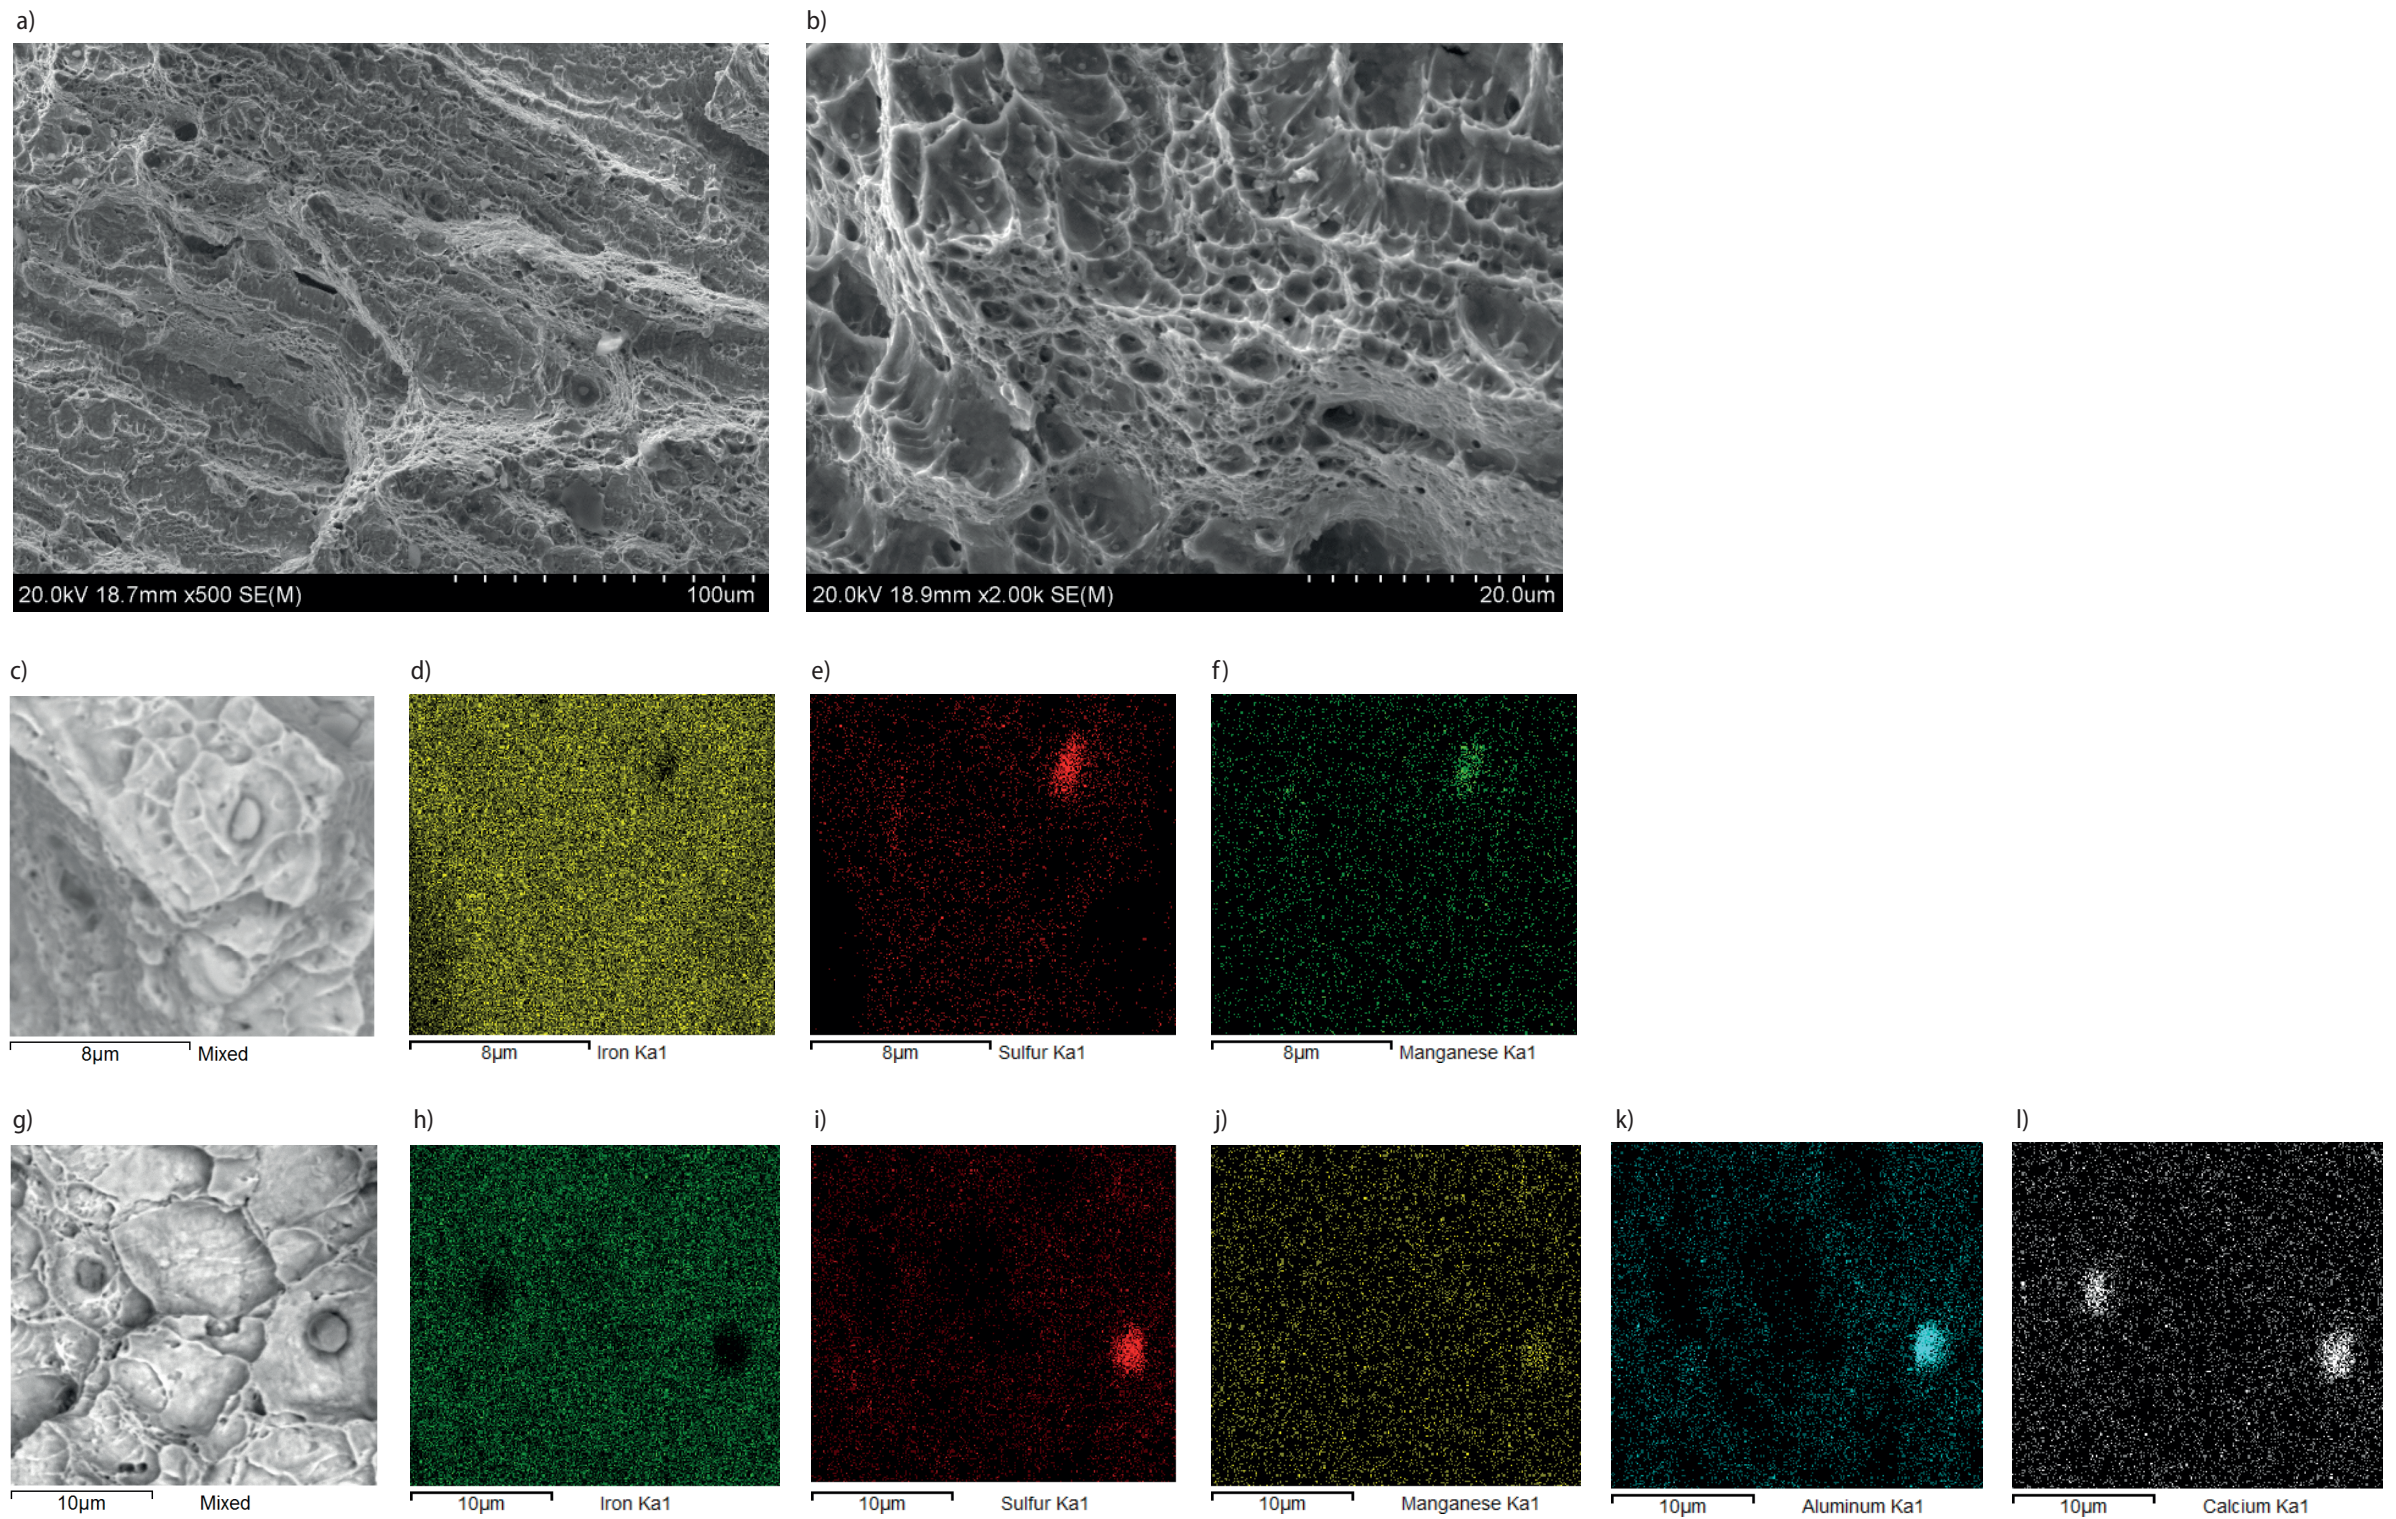
Fig. 8. Fracture of screw after Process no. 1, ruptured under laboratory conditions: a–b) SEM; c) surface for EDS analysis; d–f) EDS element map of area from Figure 8c; g) surface for EDS analysis; h–l) EDS element maps of area from Figure 8g

The rupture surface of the screw after Process no. 1 has only a transcrystalline, ductile, dimpled character (Fig. 8; on the interleaf).

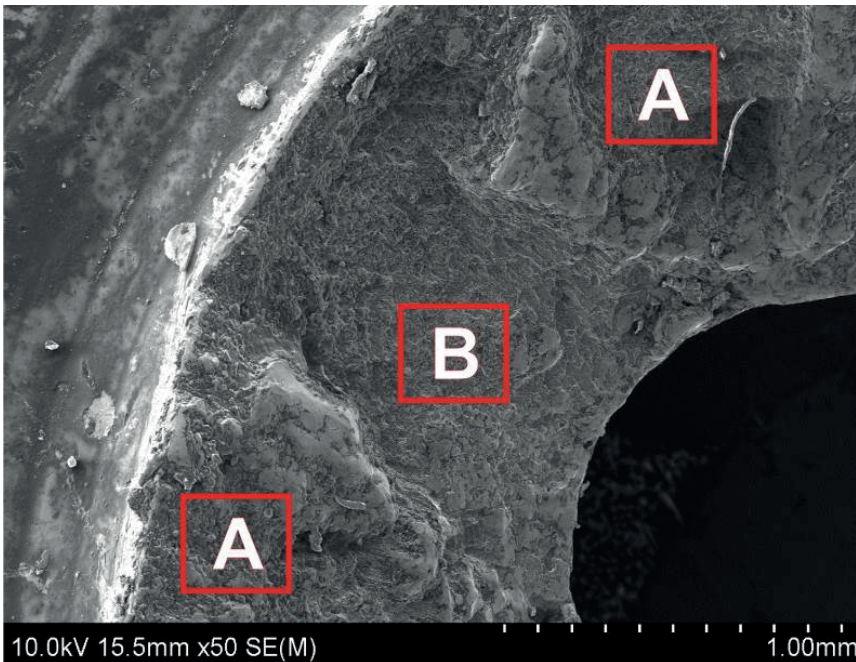
The rupture surface of the screw after Process no. 2 has two distinctly different areas (Fig. 9). In the area further from the surface, it shows a transcrystalline ductile fracture, a so-called dimpled rupture (Fig. 10). In the area closer to the surface, it shows a brittle intergranular fracture, indicating the occurrence of decohesion at the grain boundaries (Fig. 11).

Fig. 9. Fractography of screw after Process no. 2 with two distinctly different areas (A and B)

2. The rupture surface of the screw after Process no. 2 has two distinctly different areas. In the area further from the surface of the screw, it shows a transcrystalline ductile fracture, a so-called dimpled rupture. In the area closer to the surface, it shows a brittle intergranular fracture, indicating the occurrence of decohesion at the grain boundaries. In the screw after Process no. 1, the entire rupture area shows a transcrystalline ductile fracture.

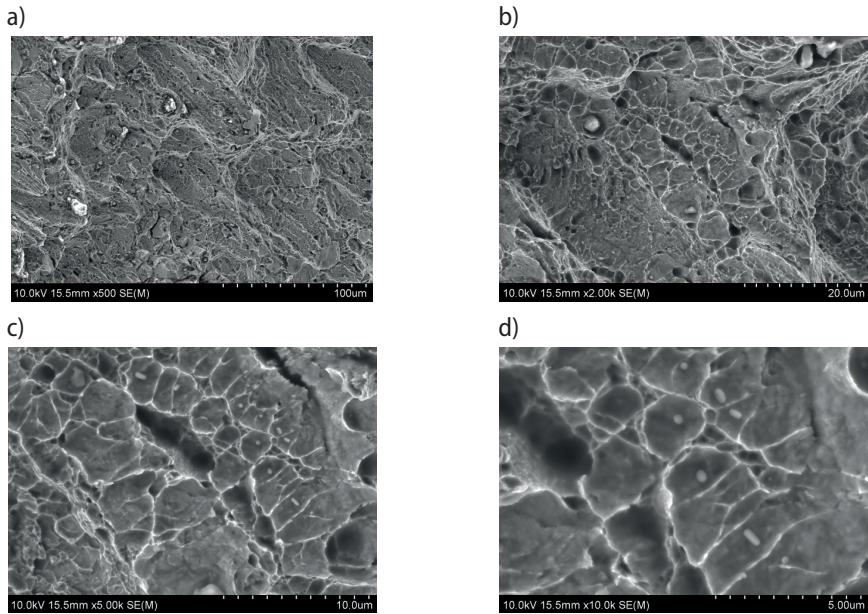
Fig. 10. Fracture surface of Area A further from screw surface, screw after Process no. 2, SEM, magn. $\times 500$ (a); $\times 2000$ (b); $\times 5000$ (c) and $\times 10000$ (d)

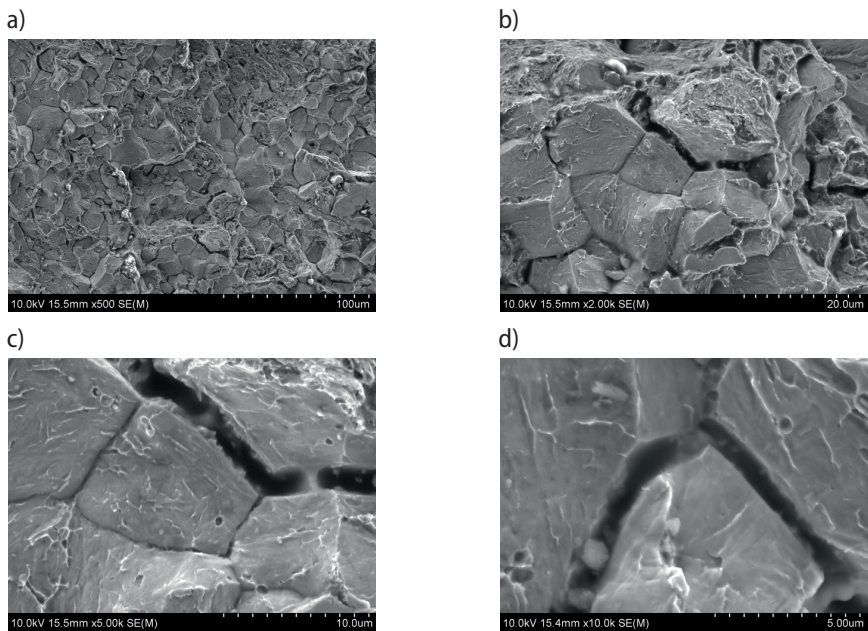
This brittle intergranular fracture corresponds to the hydrogen-assisted cracking [8, 9]. The process that exposes the steel to hydrogenation is galvanization [10, 11]. The effect of hydrogen on the mechanical behavior of steels is twofold: it affects its local yield strength, and it accelerates material damage. On the other hand, the diffusion behavior is influenced by hydrostatic stress, plastic deformation, and the strain rate. This requires hydrogen sorption and diffusion [12–16]. For this reason, trapping and diffusion of the hydrogen depends on the microstructure [17].

Fig. 11. Fracture surface of Area B further away from screw surface, screw after Process no. 2, SEM, magn. $\times 500$ (a); $\times 2000$ (b); $\times 5000$ (c) and $\times 10000$ (d)

3. Most likely, the brittle intergranular fracture is caused by the presence of hydrogen in the microstructure of the screw after Process no. 2 (coming from the electrolytically zinc coating).
