**Łukasz Rakoczy, Lechosław Tuz, Krzysztof Pańcikiewicz**

## Hot cracking of nickel-based superalloy turbine blade

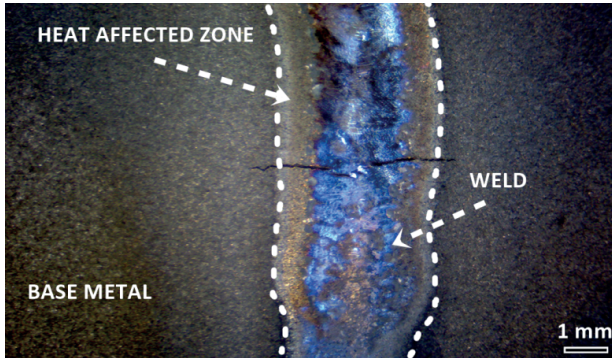
In the macrostructure (Fig. 4a), a crack was observed over the entire width of the melted region. The crack did not stop at the fusion line; as a result, liquation of the grain boundary and high stress expanded in the direction of the base material through the heat-affected zone (Figs. 4b, 4c).

Fig. 4. General location of crack obtained during repair welding

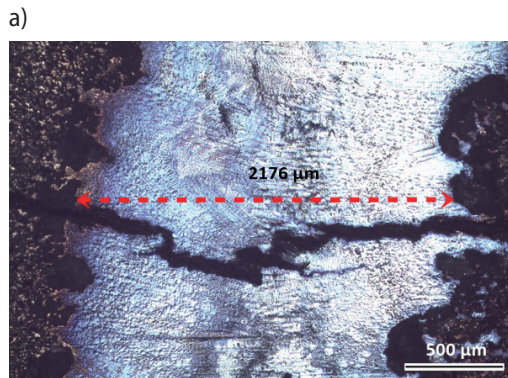
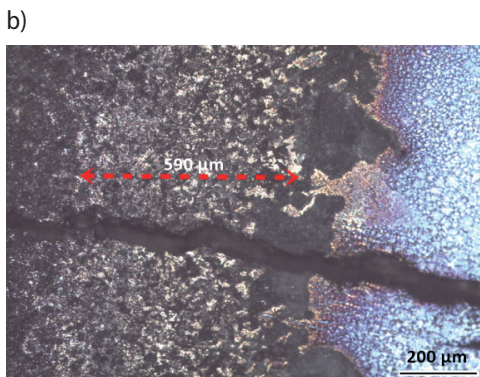
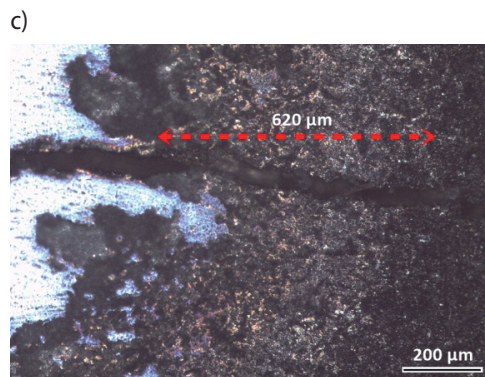
As a result of welding, the width of the melted area is just over 2 mm (Fig. 5a), while the heat-affected zones are about 600  $\mu\text{m}$  (Figs. 5b, 5c). The dimension of the crack in the base metal is shown in Figure 6.

Fig. 5. Dimension of investigated regions: a) melted region; (b, c) HAZ

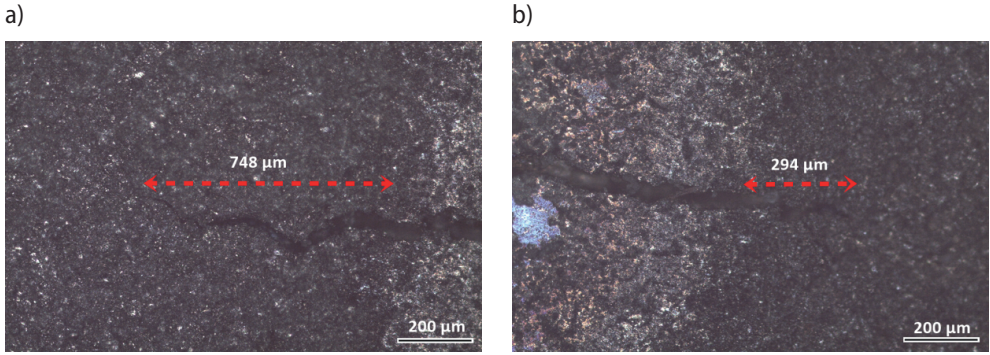
Fig. 6. Length of crack in base metal: a) left side; b) right side

On the left side, the crack developed into the base metal through 748  $\mu\text{m}$  (Fig. 6a), and so the total length of the crack (HAZ and BM) on this side is about 1350  $\mu\text{m}$ . On the other side, the crack is shorter – only about 915  $\mu\text{m}$  (Fig. 6b). The difference in the crack’s dimensions is probably the result of different heat conductivity in the base metal near

the tip and on the opposite side. The crack on the right side is located near the leading edge, and so the higher cooling rate did not allow it to propagate a greater distance into the base metal (the thickness of the base metal near the leading edge is lower). Figures 7 and 8 illustrate more details about the microstructure of the crack.

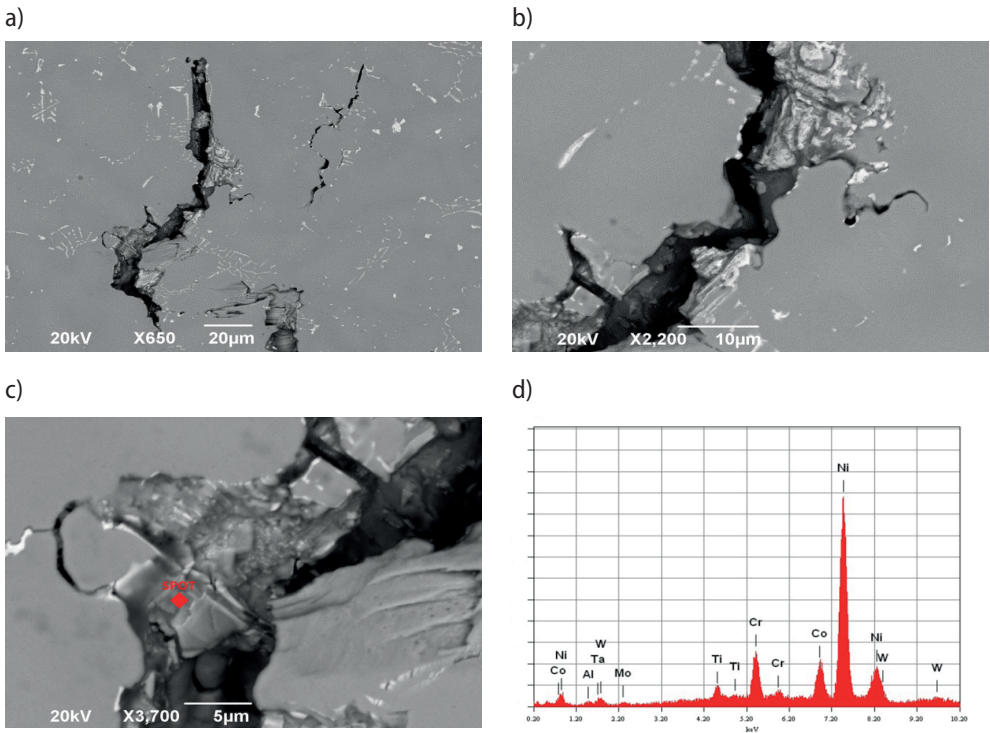
Fig. 7. Microstructure of crack: a) general view; b) liquated carbides; c) location of EDS spot; d) EDS spectrum

An SEM investigation allows us to state that the crack propagated in close proximity to the carbides and eutectic (Fig. 7a). The solidus temperature of the base material is higher than the incipient melting temperature of the eutectic and carbides; so, liquid was present during the welding process along the grain boundaries (Fig. 7b). The thermal stresses and melted constituents caused failure and did not allow us to repair the component. The energy dispersive x-ray spectroscopy analysis shows that the selected area cracked near eutectic  $\gamma/\gamma'$  (Figs. 7c, 7d).

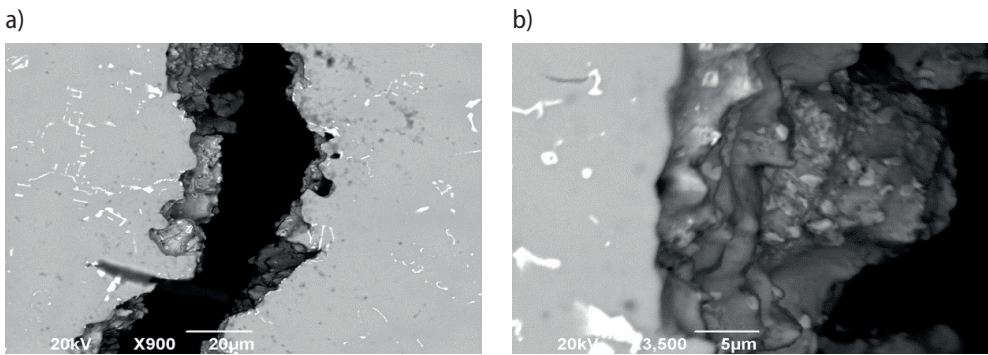
Fig. 8. Change of crack microstructure: a) increased width; b) fracture with carbide precipitates

The greater temperature gradient and increased stresses contributed to the change in the crack's microstructure. The crack in the selected region was wider, while on the edges, the base metal was fully melted (Fig. 8). Figure 8b illustrates the fracture of hot crack and primary carbide precipitates with diameters of about 1  $\mu\text{m}$ .
