Janusz Krawczyk*, Jerzy Pacyna*

THE ROLE OF METALLURGICAL DEFECTS AND MICROSTRUCTURE ON FAILURE FORMATION IN ROLL NECKS OF CAST IRON ROLLS

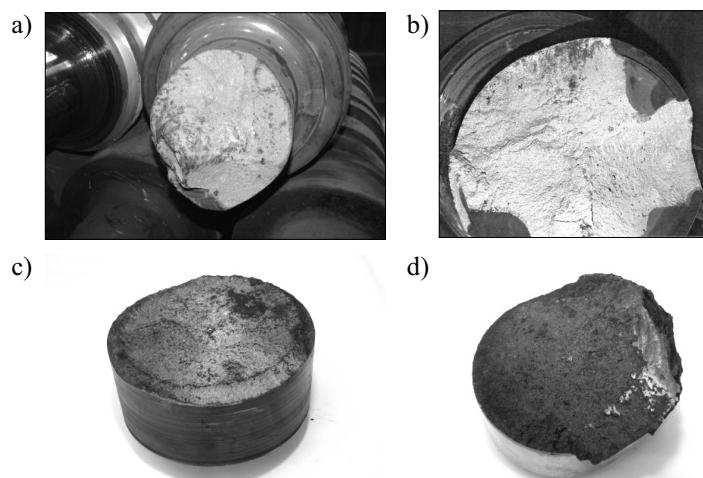
Fig. 1. Damaged roll necks: a) roll No. 1 after roll neck break off; b) roll No. 2 after roll neck break off; c) broken off part of the neck of the roll No. 3; d) broken off part of the neck of the roll No. 4

phase, neighbouring with shrinkage porosity. These cracks propagate from the core of the roll neck (areas, where shrinkage porosity exists), along the maximum sheer stresses (acting during roll bending) towards the roll face (Fig. 1a, b). Such character of a damage of the roll neck should always lead to investigation of metallurgical faults inside the roll neck core, as the most probable reasons for damage formation. It is worth to notice, that shrinkage porosity forms particularly easy in the upper part of the casting, what should be taken into account while choosing which roll neck should be placed on the side of the roll drive.

Described above disadvantageous morphology of transformed ledeburite was the reason for failure of the rolls No. 3 and No. 4 (see Figs. 1c, and 1d), but shrinkage porosity was not observed in their microstructure. The way of development of original fatigue crack was mostly influenced by the state of sheer stresses in the neck of these rolls. That is why in roll No. 3 the crack propagates to a depth of about 15 mm by “jumping” over from one band of ledeburite to another. When this fatigue crack reached the critical length, the microstructure (banding) had predominant influence on its development. Similar mechanisms were observed in the case of the roll No. 4 with this only difference that initial crack developed only on one side of the roll neck (see Figs. 1c and 1d).

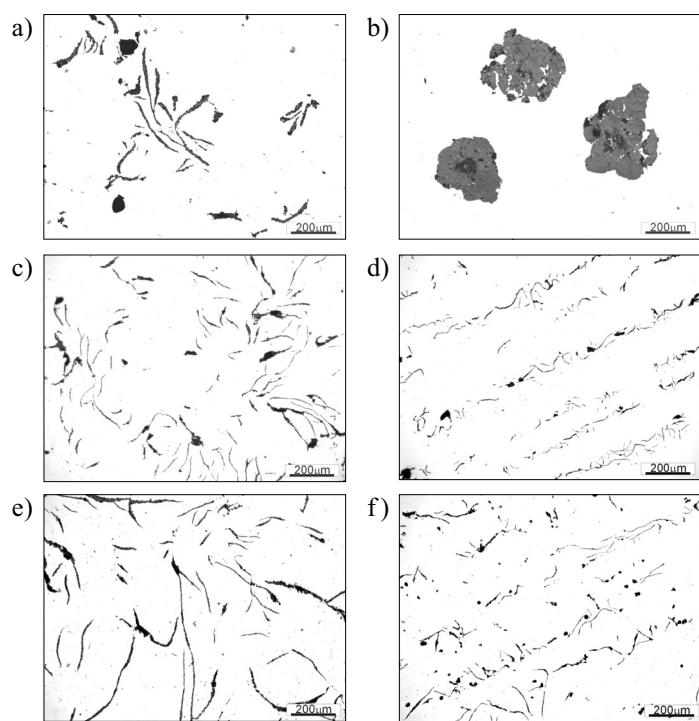
For investigation of reasons for failure of rolls necks four rolls were chosen (Fig. 1). The chemical composition of the rolls is shown in Table 1. Roll No. 2 was made of cast iron with modular graphite, and rolls No. 1, 3, and 4 were made of cast iron containing flake graphite (Fig. 2). It should be noticed, that morphology of graphite precipitates in the case of the rolls No. 3 and 4 is different in the core of the roll neck than that in the vicinity of its surface (Figs. 2c÷f). It results from the conditions of crystallization. In the vicinity of the roll neck surface a banding character of graphite precipitates could be noticed (Figs. 2d, f).

Fig. 2. Precipitates of graphite in investigated rolls: a) roll No. 1; b) roll No. 2; c) roll No. 3 (precipitates of graphite in the core of the roll neck); d) roll No. 3 (precipitates of graphite near the surface of the roll neck); e) roll No. 4 (precipitates of graphite in the core of the roll neck); f) roll No. 4 (precipitates of graphite near the surface of the roll neck)

7. The use of flake graphite cast iron for metallurgical rolls increases a risk of the fracture of roll neck. In rugged working conditions (for example strong bending of rolls), spheroidal or vermicular graphite cast iron should be used, which is more crack resistant [5].

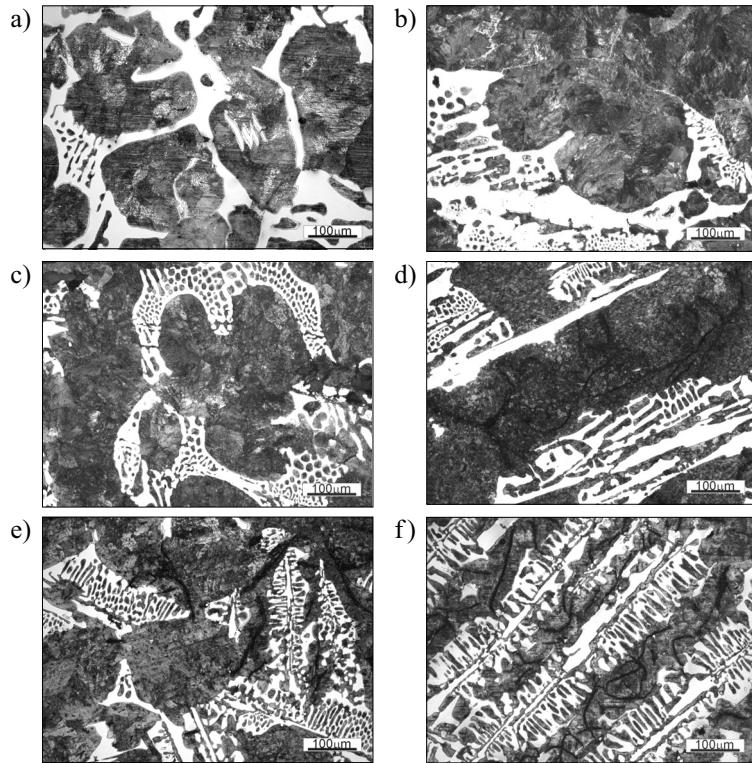
Fig. 3. Microstructure of investigated rolls: a) roll No. 1, b) roll No. 2, c) roll No. 3 (core of the roll neck), d) roll No. 3 (near the surface of the roll neck), e) roll No. 4 (core of the roll neck), f) roll No. 4 (near the surface of the roll neck). Etched with 2% nital

The microstructure of investigated rolls was shown in Figure 3. In the microstructure of all investigated rolls transformed ledeburite as well as pearlite could be observed. It should also be noticed, that volume fraction of hard, but also brittle ledeburitic cementite is high in the case of rolls No. 1, No. 3, and No. 4. Besides, it forms a continuous net, which is unfavorable from the mechanical properties point of view. As can be seen, precipitations of transformed ledeburite (originally ledeburite, so eutectic mixture) and flake graphite in the vicinity of the roll neck of rolls No. 3 and No. 4 exist in a form of bands. The conditions of crystallization of the roll neck influenced such banding of its structure. Originally, dendritic crystals were formed on the surfaces, in which the flakes of graphite were precipitating, and then quasieutectic (ledeburite) precipitated out of remaining mixture.

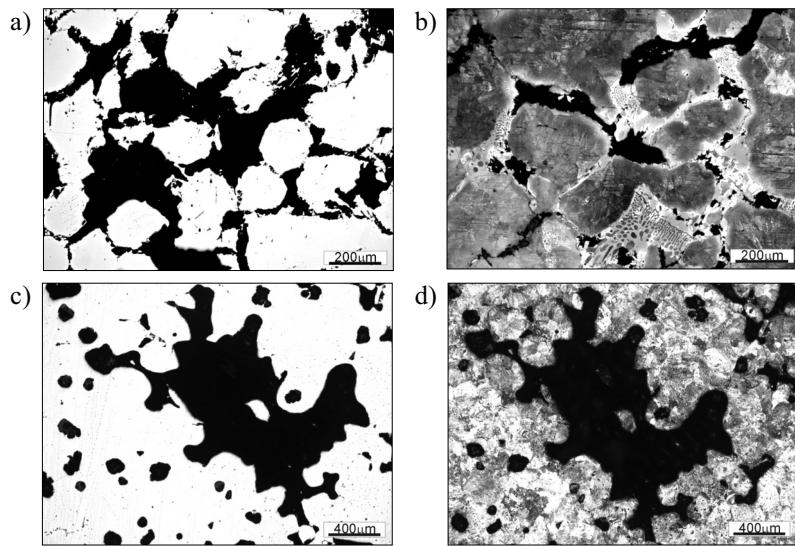
The most common reason for defects in roll necks is a presence of shrinkage porosity in their interior. In the case of investigated (damaged) roll necks, the areas of shrinkage porosity were detected in roll No. 1 and roll No. 2, what was shown in Figure 4. As can be seen, the pores are distributed in the areas where eutectic should exist. Such porosity is most common place of crack nucleation. Then, these cracks propagate along brittle carbide

Fig. 4. Shrinkage porosity area: a) roll No. 1 (unetched cross-section); b) roll No. 1 (etched cross-section); c) roll No. 2 (unetched cross-section); d) roll No. 2 (area from Fig. 4c after etching). Etched with 2% nital

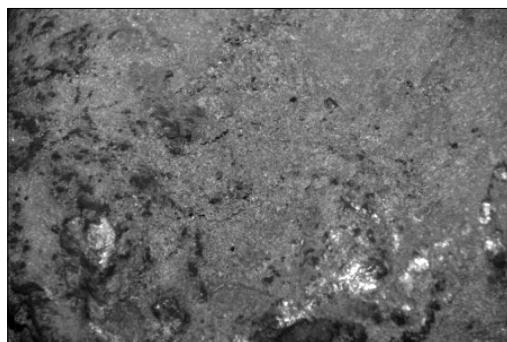
Fig. 5. The area of shrinkage porosity on fracture surface of the roll No. 1

Macroscopic observations of the roll neck can also allow identifying the shrinkage porosity. Figure 5 shows the fracture surface of the roll No. 1, where shrinkage porosity can be noticed.

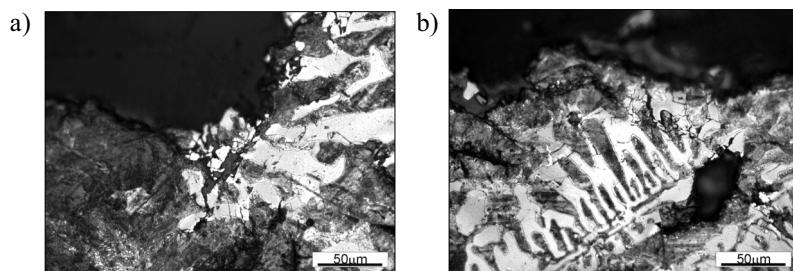
Fig. 6. Fracture propagating through the precipitates of ledeburitic cementite (roll No. 4): a) selected area; b) second selected area. Etched with 2% nital

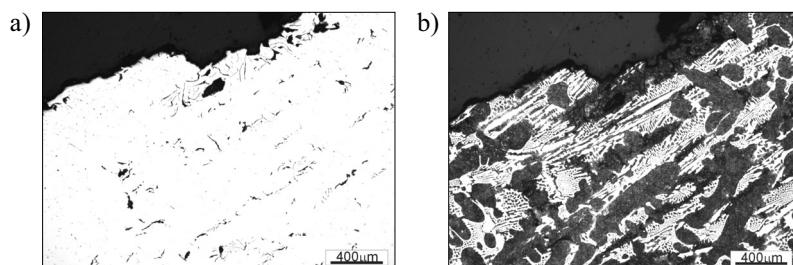
Fig. 7. Fracture propagating along ledeburitic cementite bands (roll No. 3): a) unetched cross-section; b) area from Fig. a after etching. Etched with 2% nital

In the microstructure of rolls No. 3 and No. 4, flake graphite precipitates facilitated crack migration from one band of transformed ledeburite to another (Fig. 8). The bands of flake graphite precipitates also formed the paths for crack development (Figs. 7 and 11).

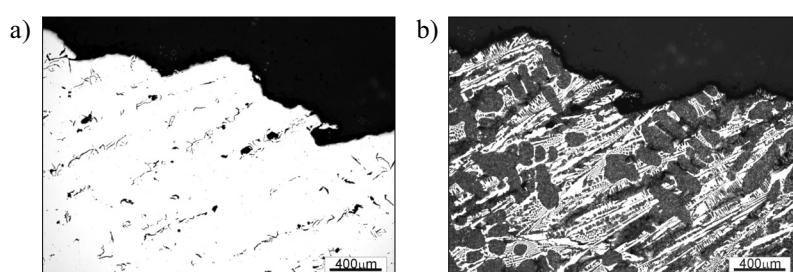
In the microstructure of almost all rolls (except roll No. 2), continuous net of ledeburitic cementite exists (with cementite built up on it, precipitated from austenite in the result of decreasing solubility of carbon in austenite ongoing with a decrease of the temperature). This continuous net of ledeburitic cementite facilitates crack propagation (Fig. 6). In the case when precipitates of ledeburite are in a form of bands, cracks will propagate along these bands (Fig. 7). If stresses cause different than parallel to these bands direction of cracking, then cracking will propagate by “jumping” over from one band to another through “cementite bridges” between them (Fig. 8).

Fig. 8. A profile of the fracture in the surface area of damaged neck of the roll No. 3: a) unetched cross-section; b) area from Fig. a after etching. Etched with 2% nital

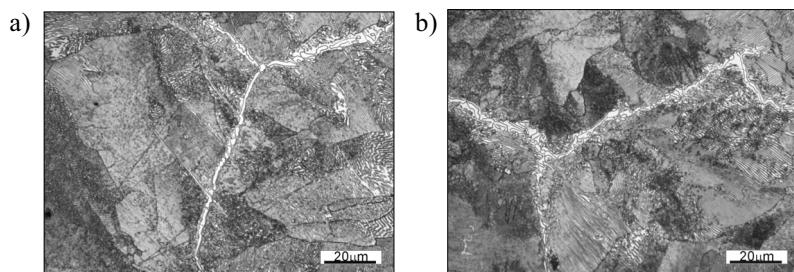
Secondary cementite in mottled cast irons can build itself on the net of transformed ledeburite, but it can also occur as independent component of the structure. Considering crack resistance, the most disadvantageous is precipitation of such cementite along grain boundaries of austenite. In the case of the roll No. 2 secondary cementite precipitated in a form of very thin, continuous net along austenite grain boundaries (Fig. 9).

Fig. 9. Continuous net of secondary cementite precipitated along boundaries of former grain of austenite in the structure of the neck of roll No. 2: a) selected area; b) second selected area. Etched with 2% nital

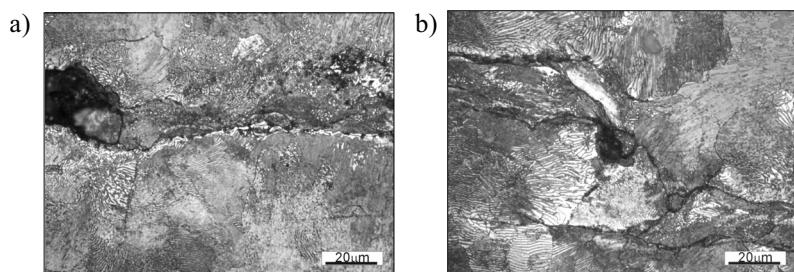
Fig. 10. Development of the crack along continuous thin net of secondary cementite (roll No. 2): a) selected area; b) second selected area. Etched with 2% nital

Even so thin net of secondary cementite significantly facilitates propagation of the crack (Fig. 10). This thin net of secondary cementite combined with shrinkage porosity became a reason for damage of the neck of the roll No. 2.

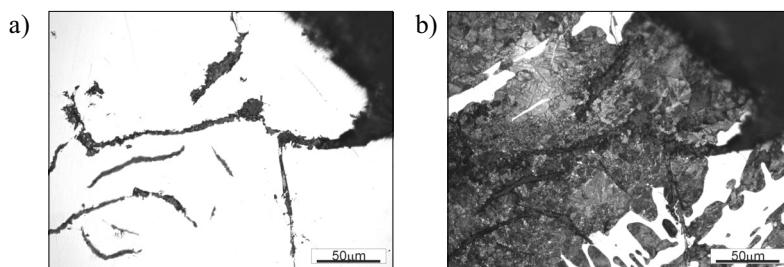
Fig. 11. Contribution of flake graphite precipitates in crack development (roll No. 3): a) unetched cross-section; b) area from Fig. a after etching. Etched with 2% nital
