# Microstructural Analysis of Concrete Using Cow Bone Ash for Alkali-Silica Reaction (ASR) Suppression

Ariyo Adanikin<sup>a,b\*</sup>, Funsho Falade<sup>a</sup>, Adewale Olutaiwo<sup>a</sup>

<sup>a</sup>Department of Civil and Environmental Engineering, University of Lagos, Akoka, Nigeria

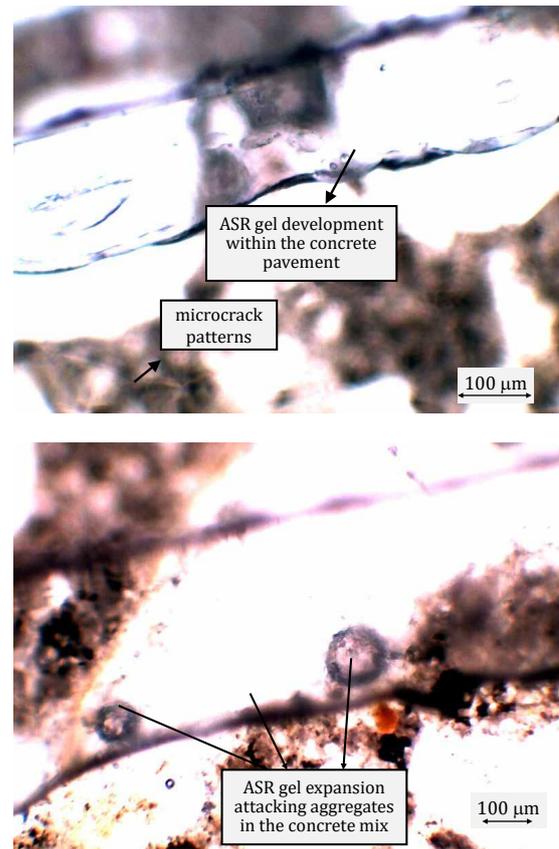
Fig. 1. Petrographic images at 0% CBA replacement

Figure 1 shows petrographic images of the concrete samples at 0% CBA replacement. High level of gel and crack formation observed. Figure 2 shows petrographic images of the concrete samples at 5% CBA replacement. ASR gel and bubbles are very visible within the concrete samples. Figure 3 shows petrographic images of the concrete samples at 10% CBA replacement. Reduced crack levels compared with 0% and 10% CBA observed. Microcracking lines also observed within the concrete sample. Figure 4 shows petrographic images of the concrete samples at 15% CBA replacement. Minimal and least amount of ASR gels and micro cracking were observed. These results can be related to flocculation and discontinuation of gel production that occurs at 15% CBA production as the CBA has sealed up the cracks and inhibited gel production. Figure 5 shows petrographic images of the concrete samples at 20% CBA replacement. Increase in gel production observed compared to 15% CBA addition. Figure 6 shows petrographic images of the concrete samples at 30% CBA replacement. ASR gel bubbles visible on concrete sample with limited microcracks.

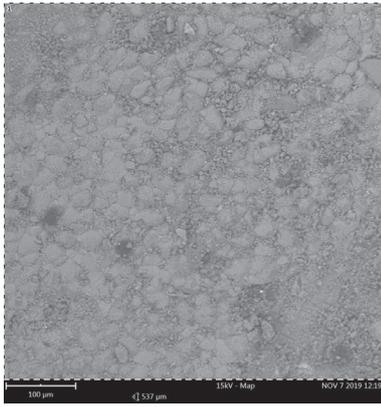
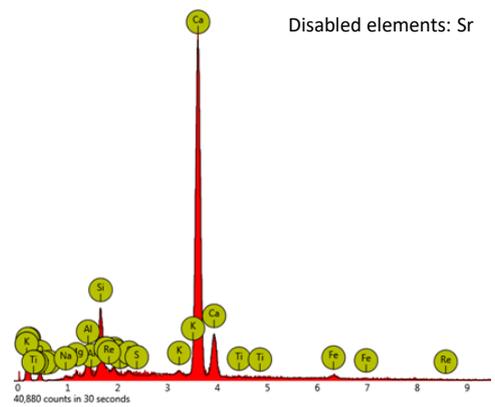
Fig. 7. SEM analysis result at 0% CBA

As shown in the Figures 7–12, high levels of calcium content by weight was observed in the concrete samples. The calcium content has a strong impact on the concrete’s strength, workability and setting time. The calcium content also strongly impacts the early strength gained by the concrete sample with 0% CBA. According to [17] the high carbon content in the concrete samples helps to decrease drying shrinkage and increases flexural toughness of concrete samples. Liu et al. [18] also stated that high carbon content in concrete enhances its compressive strength and resistance to cracking. Oxygen is also a prominent element in the concrete samples. This is in consonance with [19] that oxygen is an important binder in concrete structures and without it, rigidity of structures will be compromised. This have affected the properties of the concrete in several ways. Silicon percentages in the concrete samples also varies and plays a prominent role in the concrete’s properties as it affects the concrete strength, durability, reduces water absorption capacity and helps it to resist chloride ion penetration [20]. Several other elements exist in the concrete samples at varying atomic concentrations and weight concentrations as shown by the SEM analysis results in Figures 7–12.

Element symbol	Atomic conc. [%]	Weight conc. [g]
Ca	46.91	66.57
C	26.42	11.24
O	13.36	7.57
Si	6.37	6.34
Al	2.98	2.85
Fe	1.19	2.35
P	0.86	0.94
K	0.42	0.58
S	0.51	0.57
Mg	0.50	0.43
Ti	0.18	0.30
Na	0.32	0.26

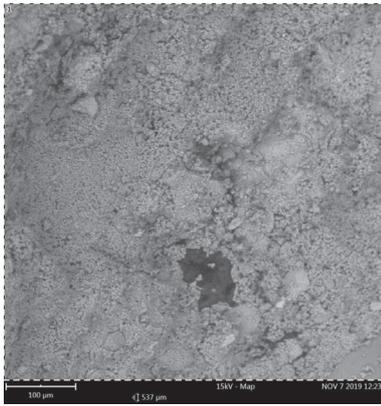
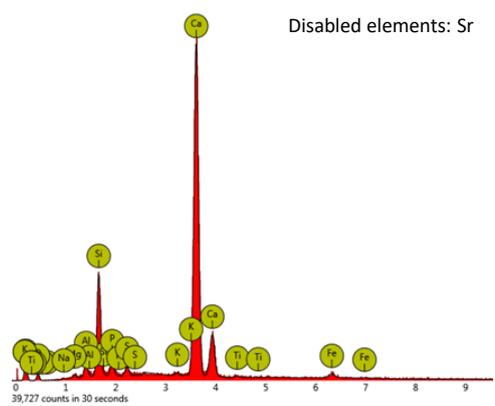
Fig. 8. SEM analysis result at 5% CBA

Element symbol	Atomic conc. [%]	Weight conc. [g]
Ca	54.05	68.79
Si	11.17	9.97
C	15.93	6.08
O	10.16	5.16
Fe	1.85	3.29
P	2.07	2.04
Al	2.03	1.74
S	1.18	1.20
Ti	0.51	0.78
Mg	0.57	0.44
K	0.33	0.41
Na	0.14	0.10

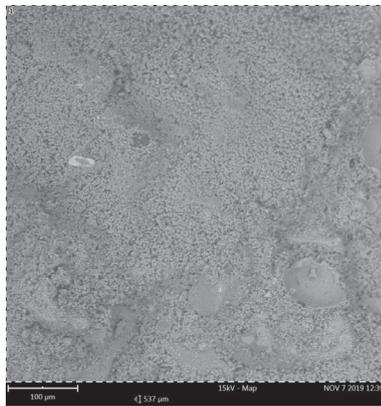
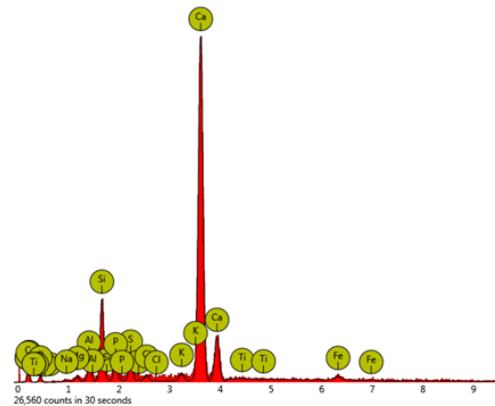
Fig. 9. SEM analysis result at 10% CBA

Element symbol	Atomic conc. [%]	Weight conc. [g]
Ca	53.24	67.85
Si	8.43	7.52
C	17.10	6.53
O	9.19	4.68
Fe	1.95	3.47
S	2.54	2.59
Al	2.52	2.16
P	2.07	2.04
K	1.02	1.27
Cl	0.76	0.86
Mg	0.76	0.58
Ti	0.18	0.27
Na	0.25	0.19

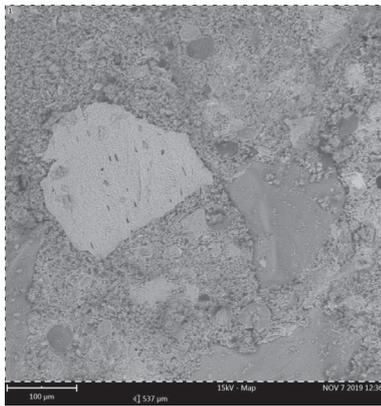
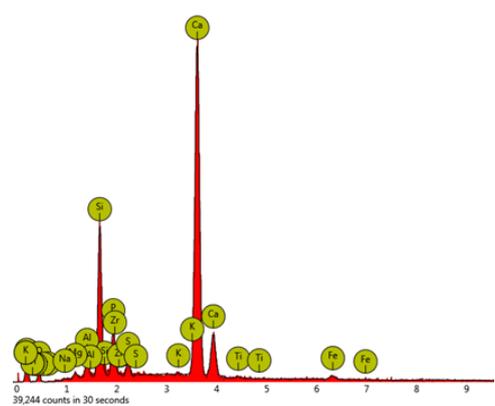
Fig. 10. SEM analysis result at 15% CBA

Element symbol	Atomic conc. [%]	Weight conc. [g]
Ca	43.66	59.20
Si	12.82	12.18
C	21.25	8.63
O	11.73	6.35
P	3.86	4.04
Zr	0.81	2.51
Fe	1.28	2.42
Al	1.90	1.74
S	1.58	1.72
Ti	0.31	0.51
Mg	0.53	0.43
K	0.12	0.16
Na	0.15	0.12

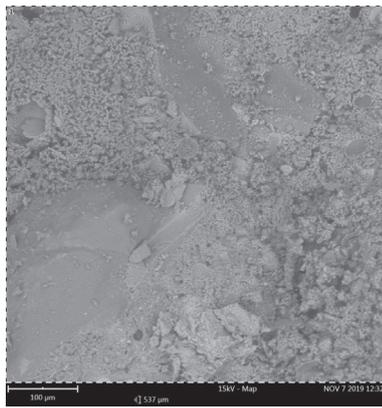
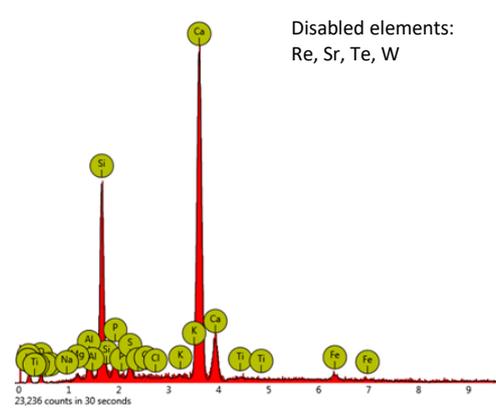
Fig. 11. SEM analysis result at 20% CBA

Element symbol	Atomic conc. [%]	Weight conc. [g]
Ca	44.44	59.11
Si	17.15	15.99
C	16.09	6.41
O	11.77	6.25
Fe	1.79	3.32
P	3.15	3.24
Al	1.94	1.73
S	1.63	1.73
Ti	0.38	0.61
Mg	0.66	0.54
K	0.39	0.50
Cl	0.27	0.32
Na	0.34	0.26

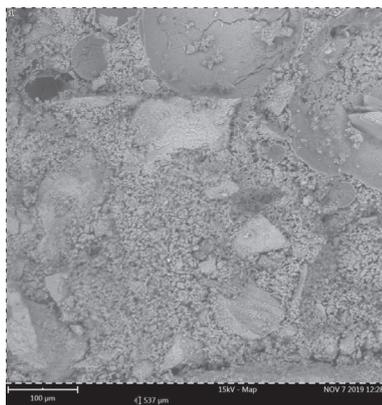
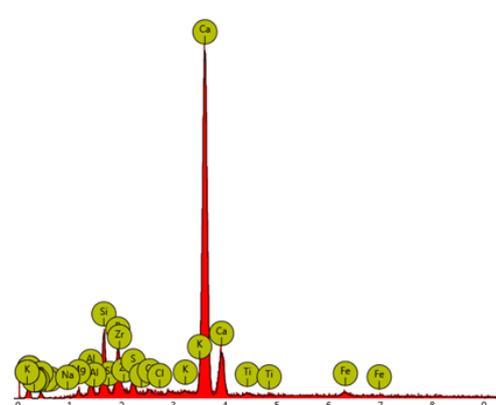
Fig. 12. SEM analysis result at 30% CBA

Element symbol	Atomic conc. [%]	Weight conc. [g]
Ca	64.43	70.93
Si	7.77	6.00
O	10.73	4.71
P	5.34	4.54
Zr	1.39	3.49
Fe	2.25	3.45
S	2.24	1.97
Al	2.24	1.66
Ti	0.71	0.93
Cl	0.79	0.77
Mg	1.07	0.71
K	0.40	0.43
Na	0.64	0.40
