EVALUATION OF THE STATE OF STRESS IN STRUCTURAL COMPONENTS OF A SCREEN SEPARATOR

This study summarises the results of FEM analysis of the state of stress generated in structural components of a PZ3R screen separator under the typical operating conditions. Simplifications underlying the numerical analysis were verified by measuring the stresses in selected parts of the machine.

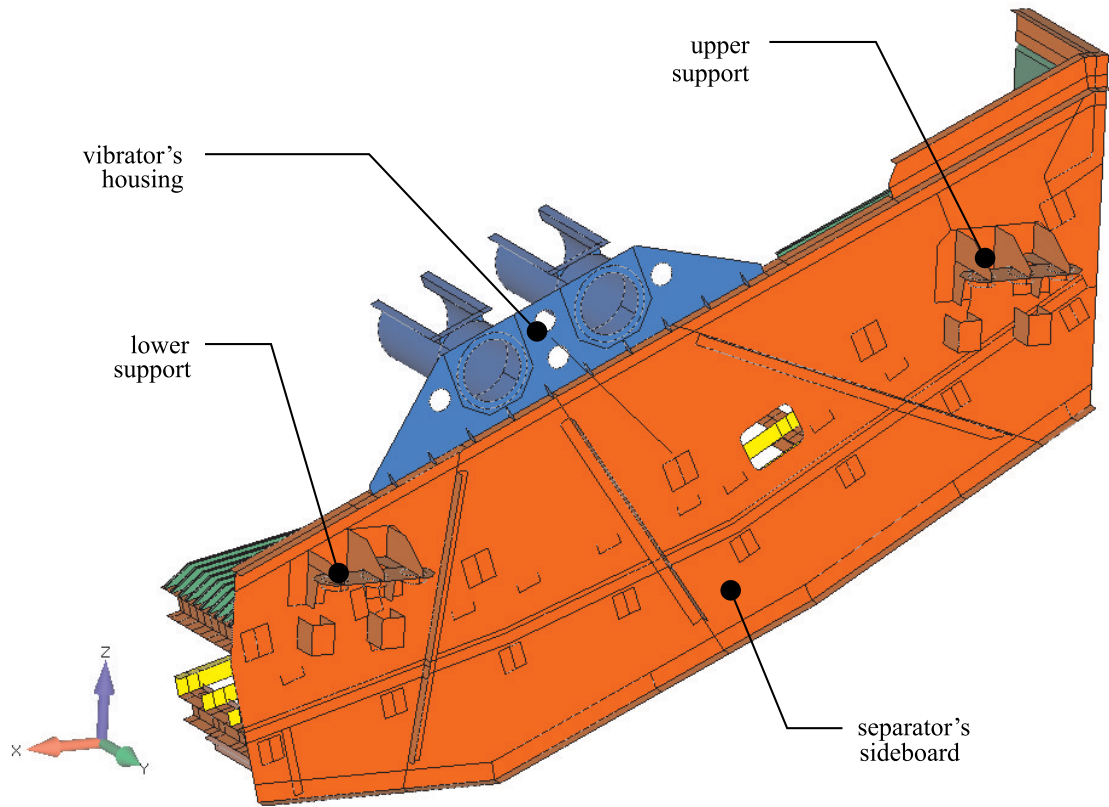
rences between PZ3R and typical PZ screen separators include: the smaller size of the sieve deck, a larger number of decks and nearly parallel arrangement of vibrators with respect to the sieve decks (Fig. 1).

Fig. 1. Longitudinal section of the PZ3R screen separator – a side view

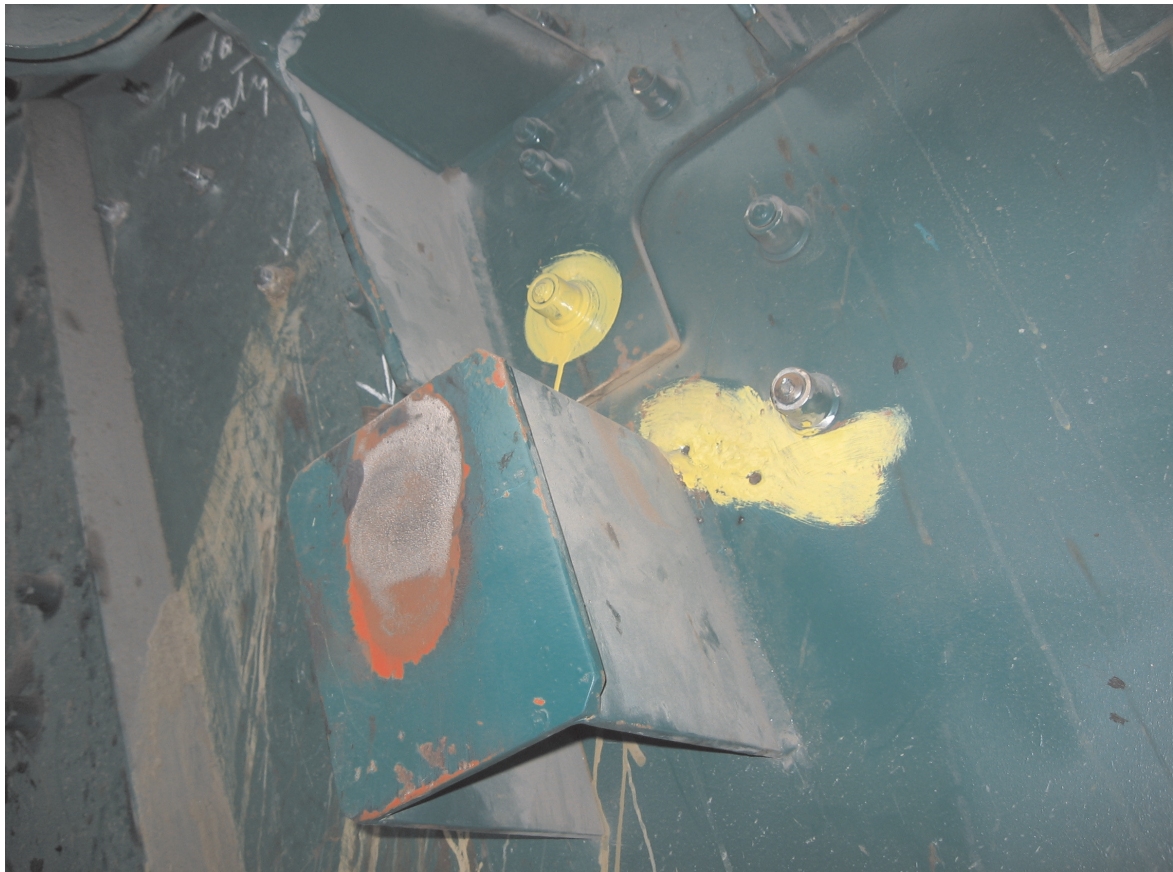
- breaks in the area of the sieve sideboard support (Fig. 2),
- lasting deformation of the support (Fig. 3).

Fig. 2. Fractures in the regions of the sieve sideboard support, damaged HuckBolt bolts

Attempts were made to restore the separator's operational efficiency through strengthening the most vulnerable points, yet the improvements were only temporary.

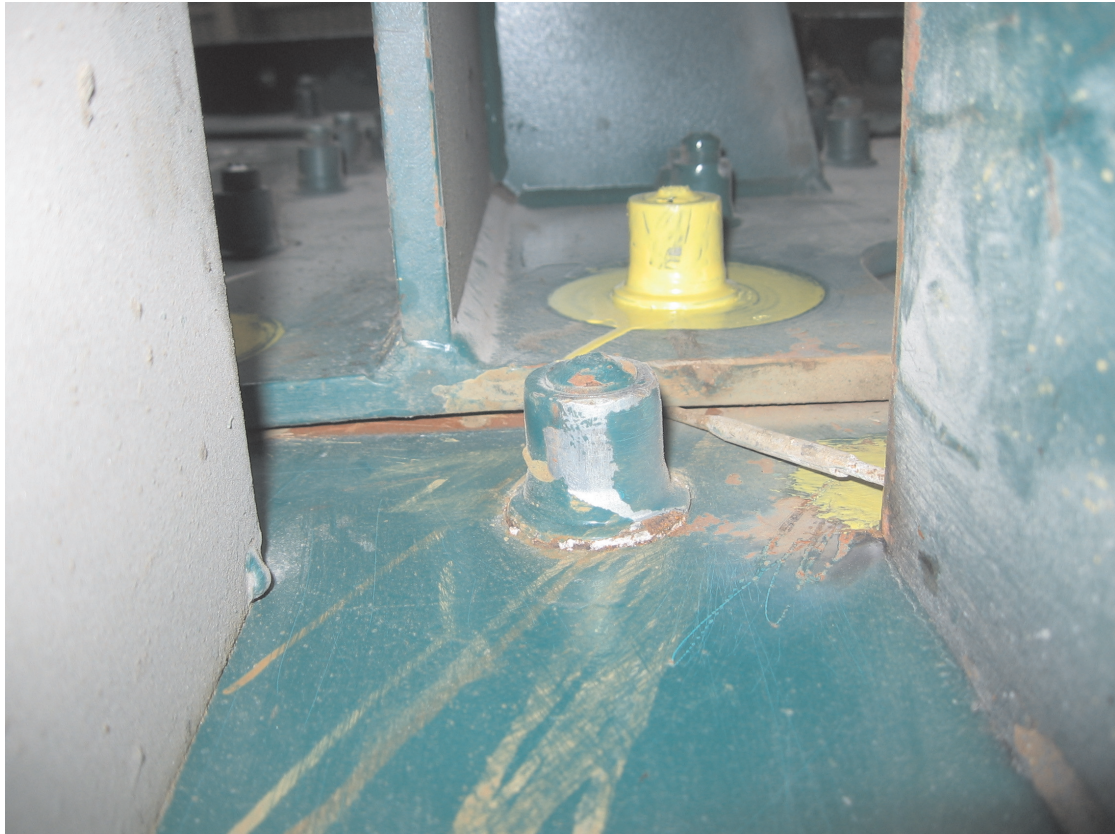
Fig. 3. Lasting deformation of the support

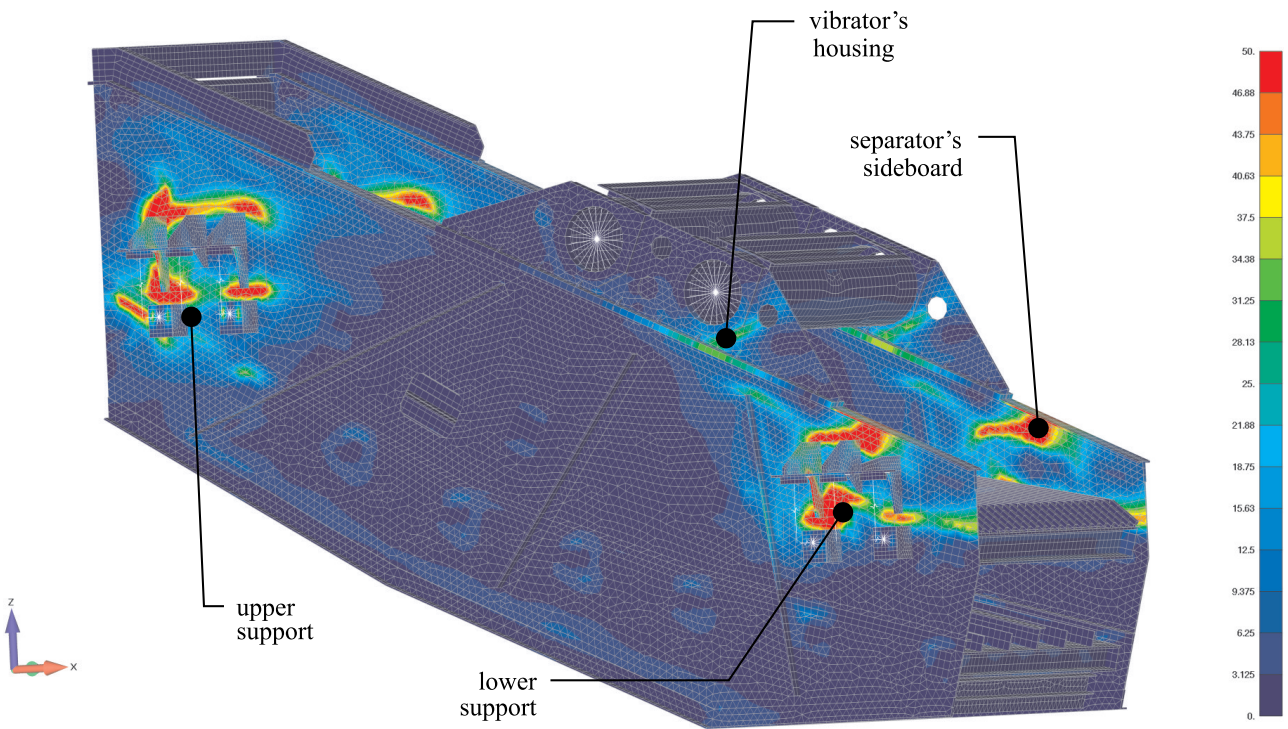
The revealed zones of stress concentration (Fig. 4) include:

- upper and lower support,
- sieve's sideboard,
- vibrator's housing.

Fig. 4. Stress concentration zones around the supports, next to the lower shaft and deck beams

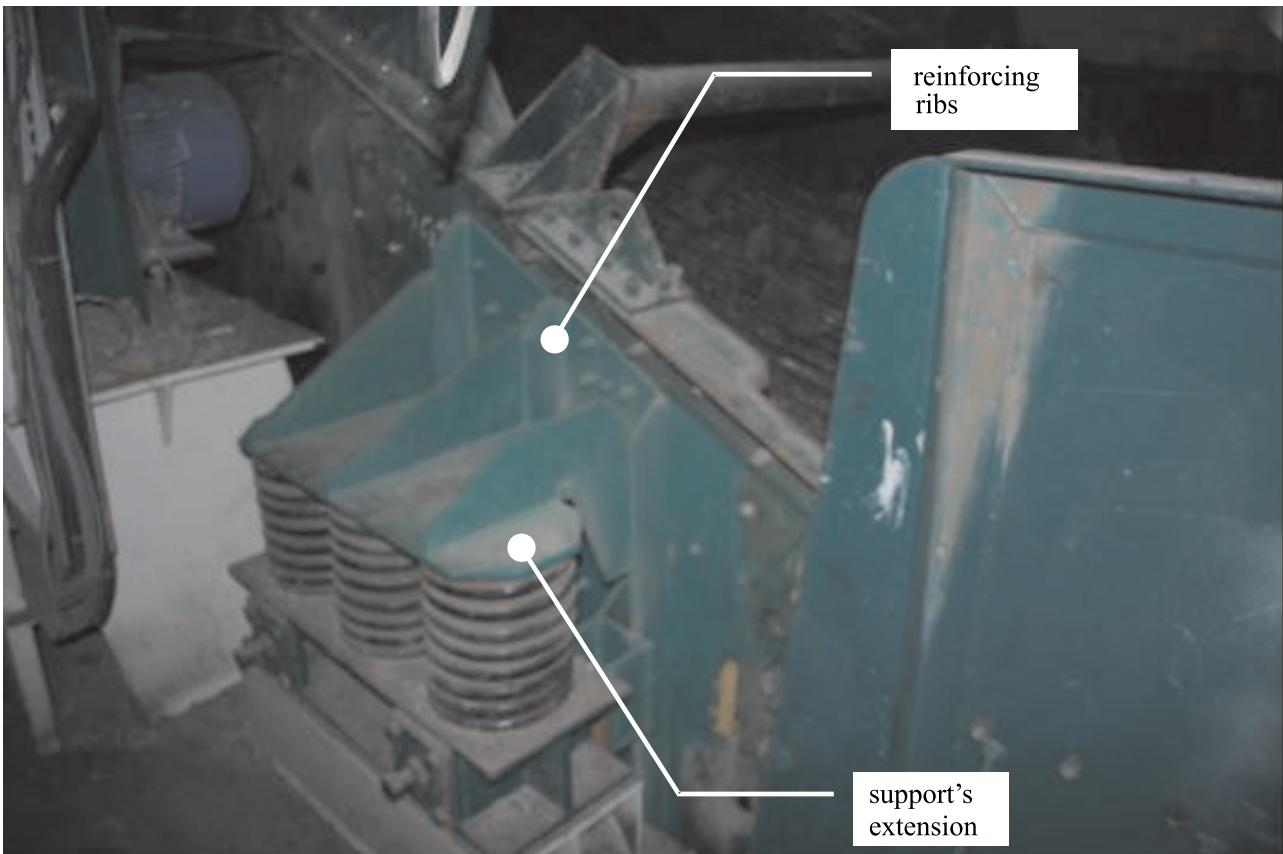
Fig. 5. Modified lower support

The results of strength analysis led the user to introduce a number of changes in the machine's design. As regard the supports, the modifications include (Fig. 5):

- support's extension shorter by 140 mm,
- modification of ribs reinforcing the sideboard, in the vicinity of supports.

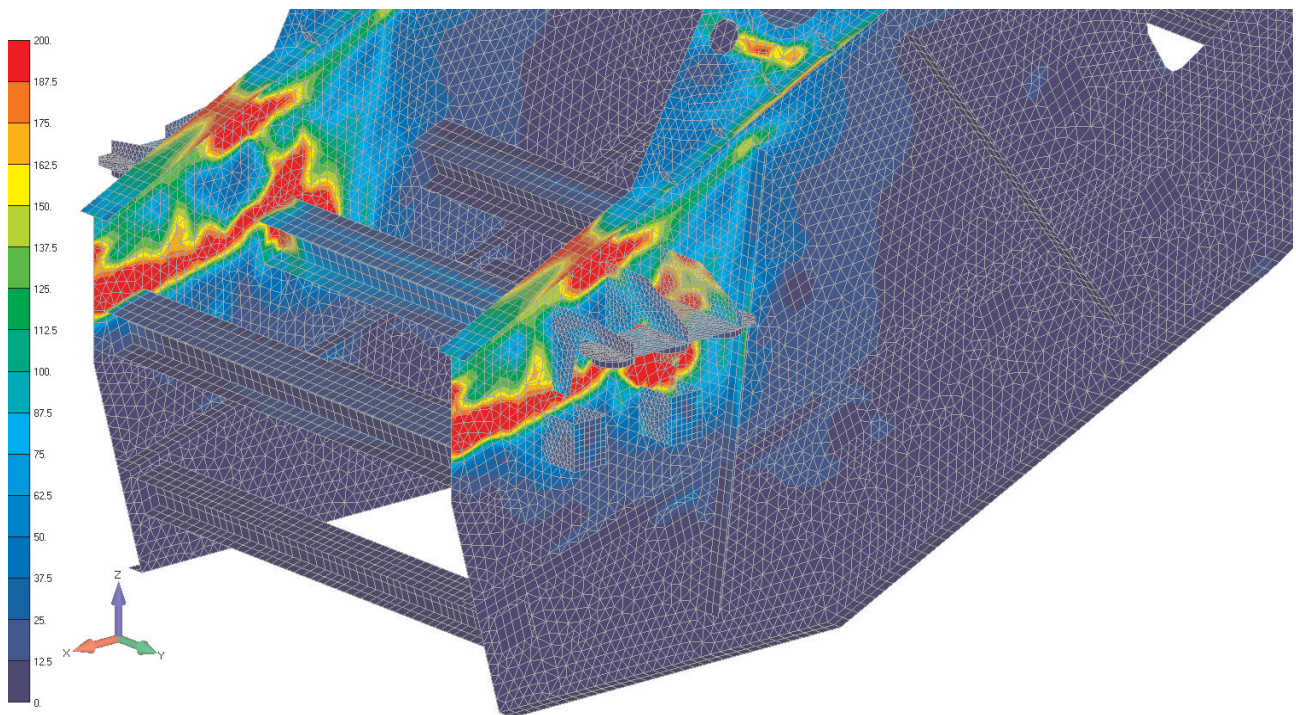
The strength analysis was related to the study of the original construction of the screen separator. The results are shown in Figure 6.

Fig. 6. State of stress (contour lines of reduced stress [MPa]) in the original construction of the separator

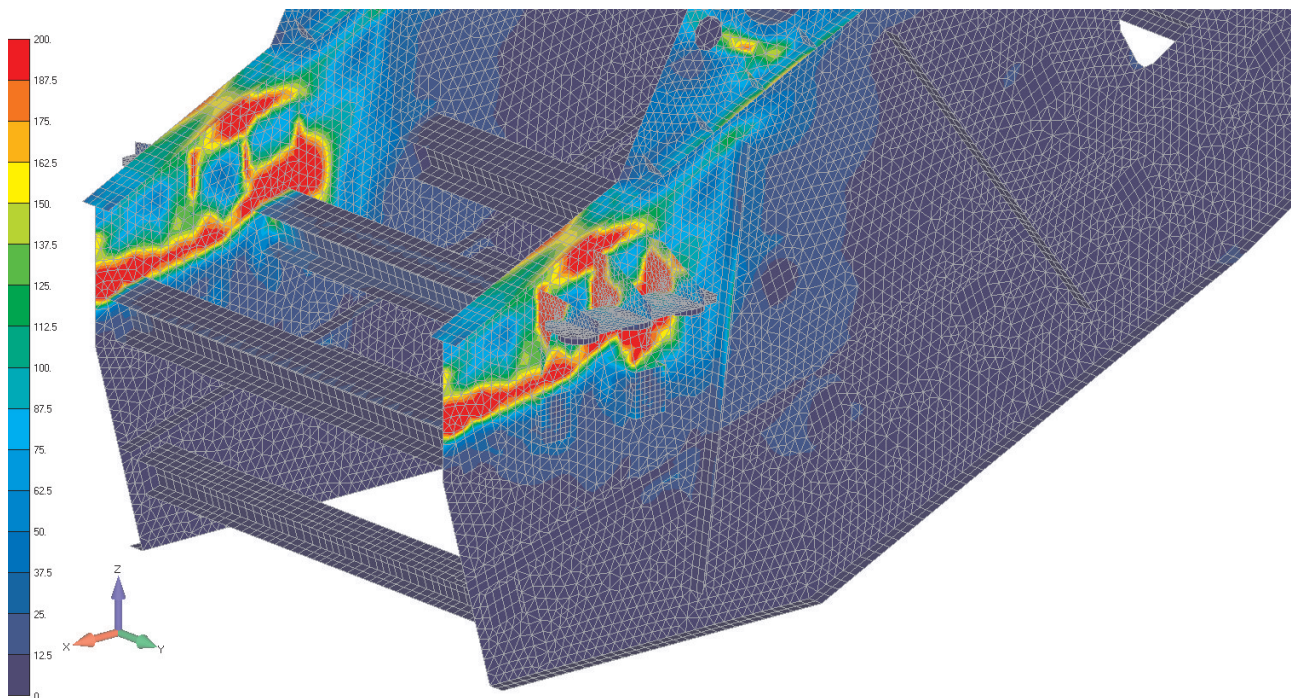
Figures 7 and 8 show the effects of design modification on the state of stress in the machine's elements in relation to that experienced in the original structure (see Fig. 6). Figure 7 shows the state of stress in the construction where the support extension has been shortened by 140 mm and Figure 8 shows the condition after the sideboard has been reinforced by welded C profiles C280.

Fig. 7. State of stress (contour lines of reduced stress [MPa]) for construction with the support's extension shortened by 140 mm

The study of the design option in which the support's extension is shorter by 140 mm indicates that re-designing the support locally is not sufficient to cause a significant decrease of stress generated in the separator's elements (Tab. 1). The solution in which the sieve's sideboards are reinforced with C profiles will lead to a considerable reduction of stress in the investigated areas (Tab. 1).

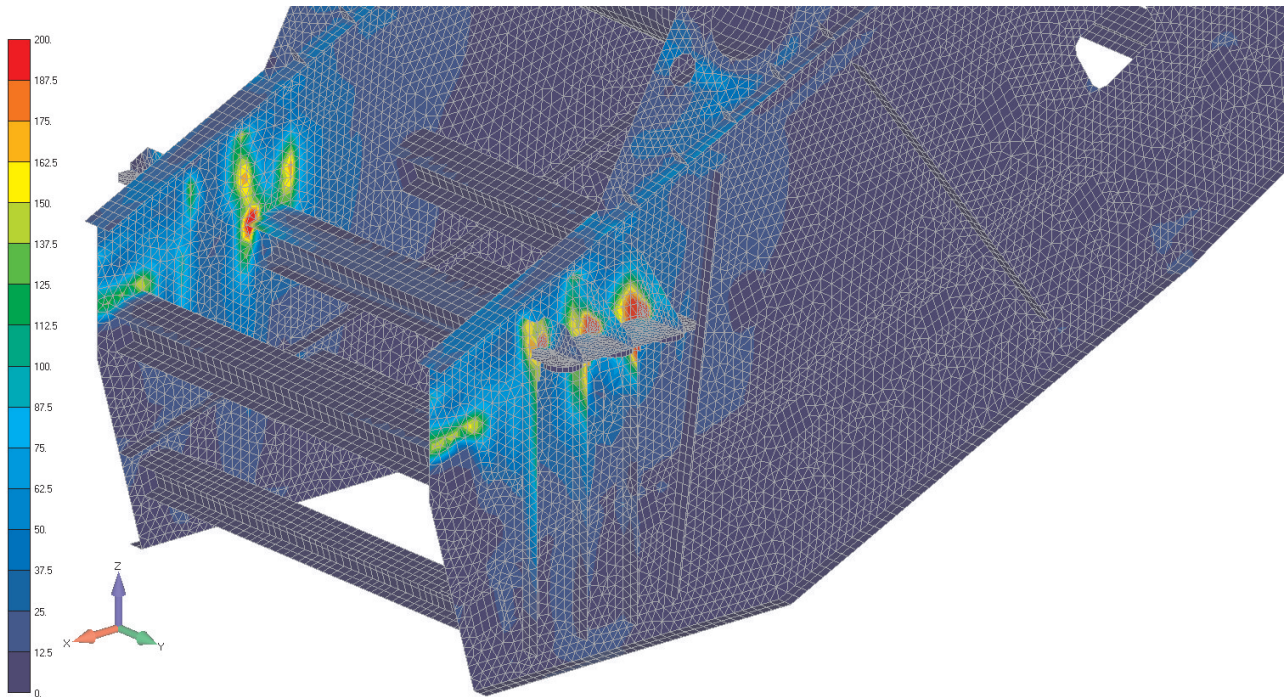
Fig. 8. State of stress (contour lines of reduced stress [MPa]) for construction with the support's extension shortened by 140 mm and with a reinforced sideboard

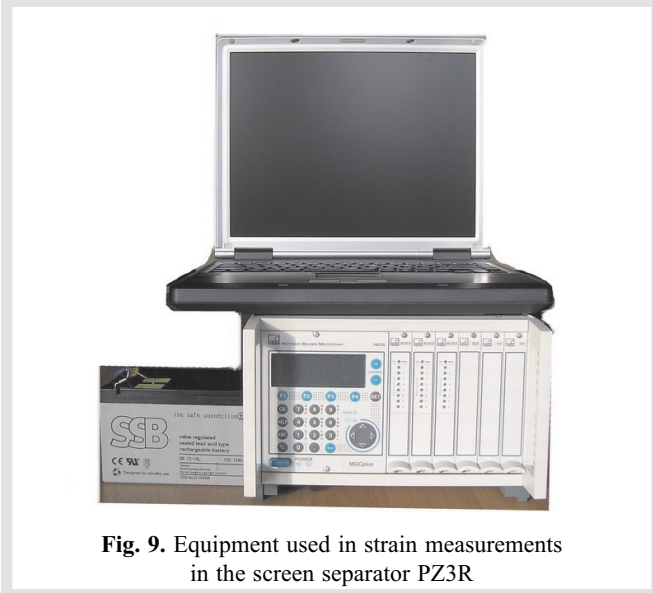
Measurements were taken with the bridge system HMB MGCPlus, adapted to handling measurements with the use of resistance and induction sensors. The bridge was connected to a portable computer (or laptop) supported by

the professional program "Catman" (HMB), which registered the signals from the sensors. The measuring equipment is shown in Figure 9 (Wolny *et al.* 2009).

Fig. 9. Equipment used in strain measurements in the screen separator PZ3R

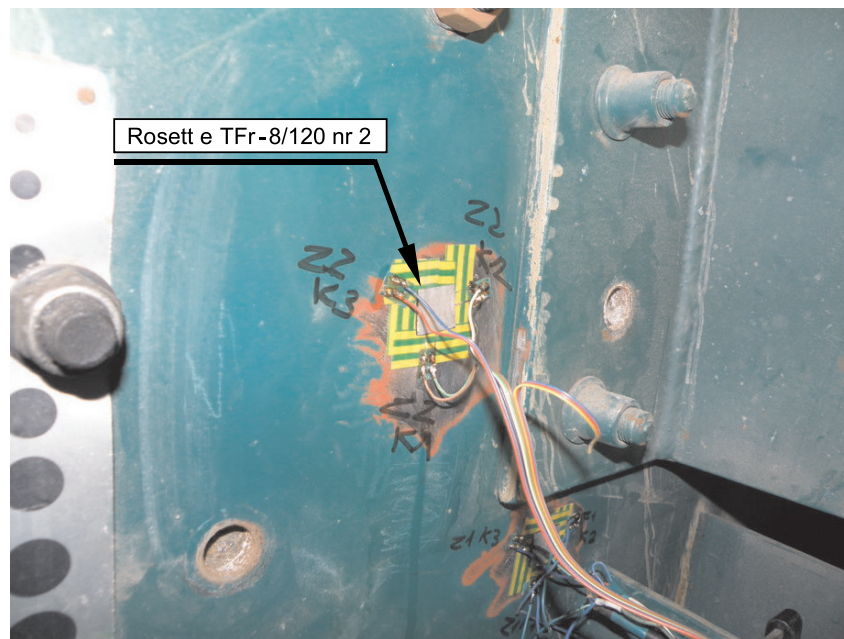
Strain rosettes were located around the attachment point of the lower support, three rosettes on each side of the structure. Delta rosettes 2 and 4 were mounted in the side section of the lower support (Fig. 10). Delta rosettes 1 and 3 were mounted in the bottom part of the lower supports (Fig. 11). In the upper part of lower supports are double-sensor rosettes (5 and 6), shown in Figure 12. Each strain gauge was temperature-compensated.

Fig. 10. Rosette 2 mounted in the side section of the separator's lower support

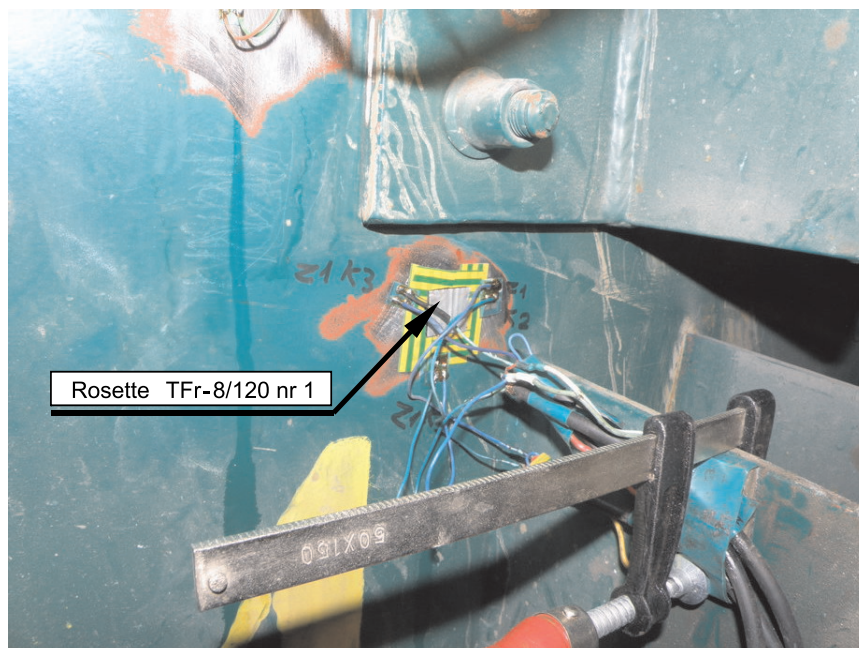
Fig. 11. Rosette 1 mounted in the bottom part of the separator's lower support

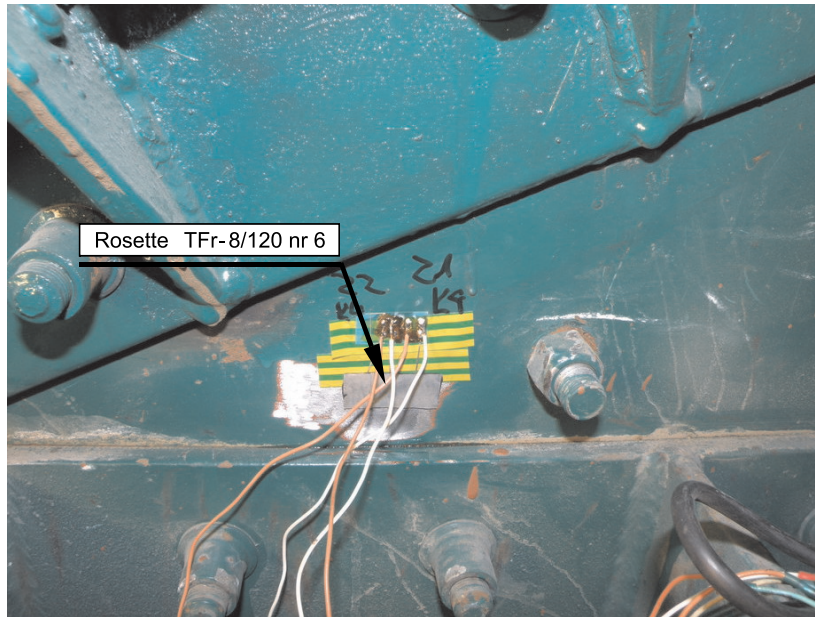
Fig. 12. Rosette 6 mounted in the upper part of the separator's lower support

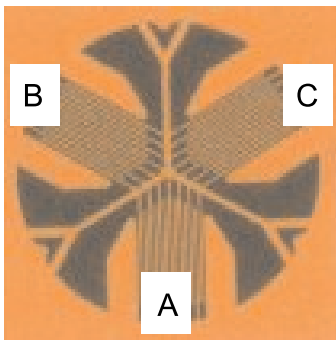
where: directions A, B, C are shown in Figure 13.

Fig. 13. Directions in the formula 1

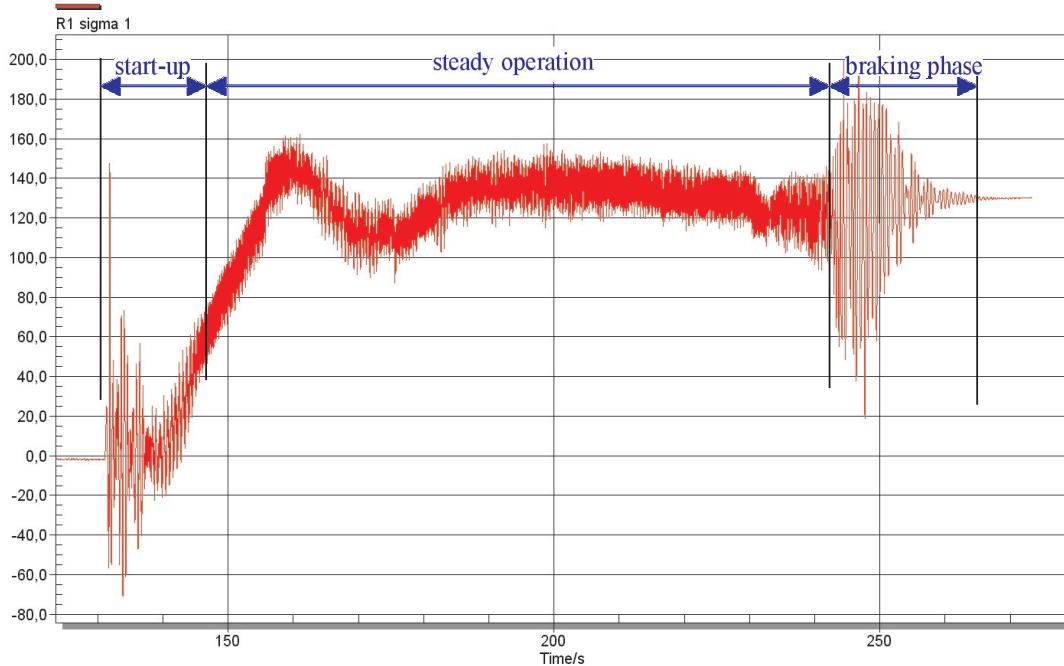
Figure 14 shows stress variations in the three phases of the screen separator's operation registered by the rosette 1, fixed in the maximal stress concentration zone identified by the numerical analysis.

Fig. 14. Stresses σ_1 registered by the rosette 1 throughout the entire duty cycle

The maximal stresses were registered by the strain rosette 1 ($\sigma_{\max} \equiv 190$ MPa) during the braking phase (Fig. 14). At the same time, the stress level read off the strain rosette 2 (Fig. 15) was $\sigma_{\max} \equiv 125$ MPa. Measurements were taken after the modifications mentioned in section 2 and thus obtained stress levels were only slightly different from those obtained at selected points on the screen separator by the numerical FEM approach.

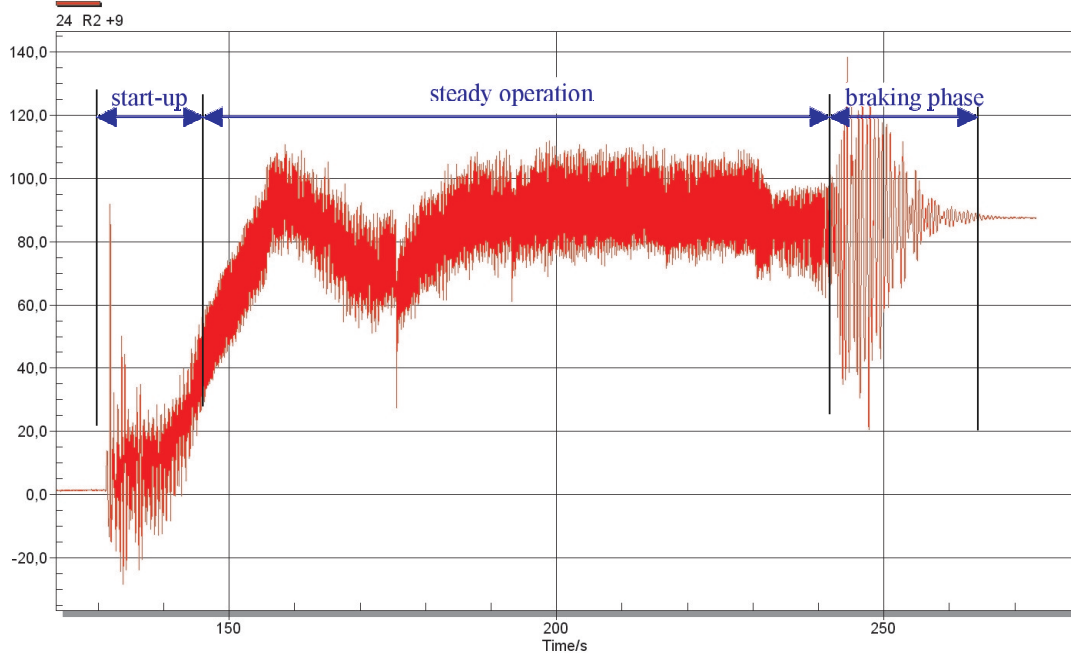
Fig. 15. Stresses σ_1 registered by the rosette 2 throughout the entire duty cycle
