**Łukasz Rakoczy, Lechosław Tuz, Krzysztof Pańcikiewicz**

## Hot cracking of nickel-based superalloy turbine blade

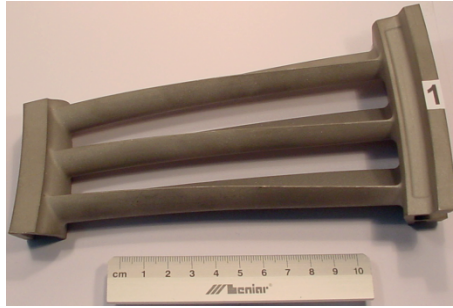
The component used in these experiment was cast the turbine segment presented in Figure 1. The element is made of the nickel-based superalloy known as MAR-M247. The chemical composition of the alloy is given in Table 1. The first stage of our investigation was to characterize the base metal microstructure. Subsequently, the airfoil of the blade was modified by Gas Tungsten Arc Welding. For this purpose, an Oerlikon welding machine was used. The parameters of the GTAW process are presented in Table 2. For light microscopy, the sample was initially ground with sandpaper (with weights of #320, #600, #800, #1000, #1200, and #2000) and then mechanically polished with diamond paste of 3  $\mu\text{m}$  and 1  $\mu\text{m}$  grits. Afterwards, the sample was electrolytically etched with a 10% solution of chromium (VI) trioxide. The investigation was carried out on a Leica light microscope. The scanning electron microscopy (SEM) examination and energy dispersive spectroscopy were conducted on a Jeol microscope operated at 20 kV. Imaging in the SEM was performed by backscattered electrons on the polished samples.

Fig. 1. Turbine segment originating from aircraft engine

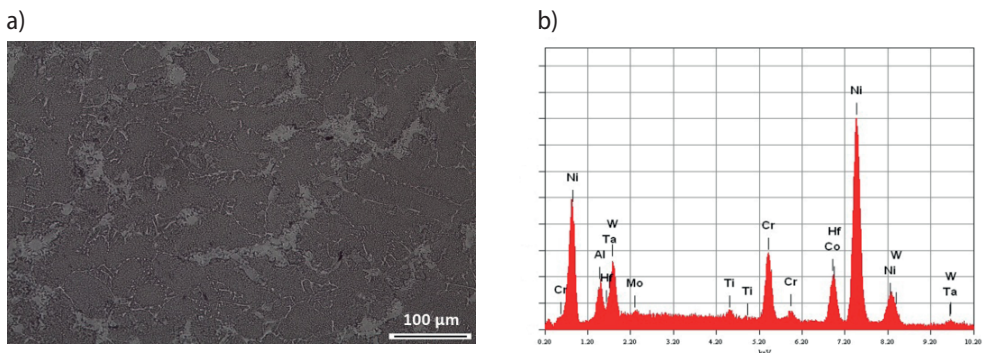
Fig. 2. Cast MAR-M247: a) microstructure; b) EDS spectrum

The microstructure revealed equiaxed grains in the blade-as-cast and after heat treatment (Fig. 2a). The obtained microstructures show that the analyzed MAR-M247 originated from a low-pressure turbine. Different methods of casting such elements allows to reach directionally solidified structure for use in the high-pressure turbine [1]. Further observations of the microstructures using a higher magnification and the EDS spectrum of carbide are presented in Figure 3.

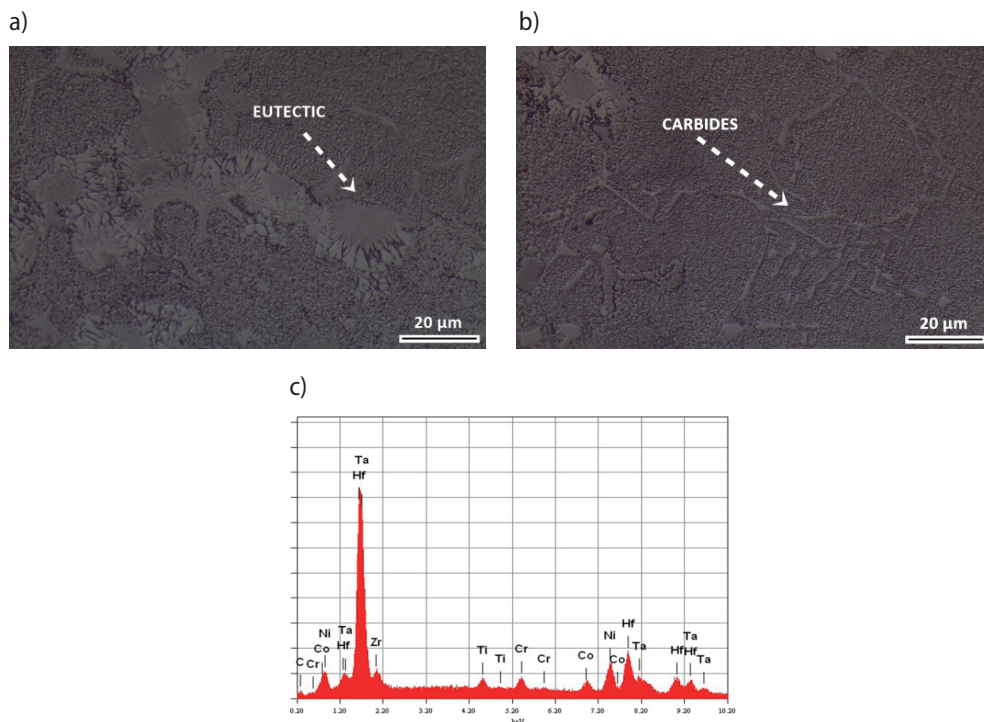
Fig. 3. Precipitation in as-received condition: a) eutectic; b) carbides; c) EDS spectrum of carbide.

It obtained that carbides as well as eutectic  $\gamma/\gamma'$  are revealed (Figs. 3a, 3b). In the microstructure,  $M_{23}C_6$ -,  $M_6C$ -, and MC-type carbides can be present [2]. Evidence of an MC-type carbide (Hf, Ta)C was confirmed during energy dispersive spectroscopy (Fig. 3c).
