**Anna Wójcicka, Krzysztof Mrocza, Marcin Kowalski**

## Non-invasive analysis and visualization of objects from FSW AlSi9Mg/2017A aluminum alloy joints

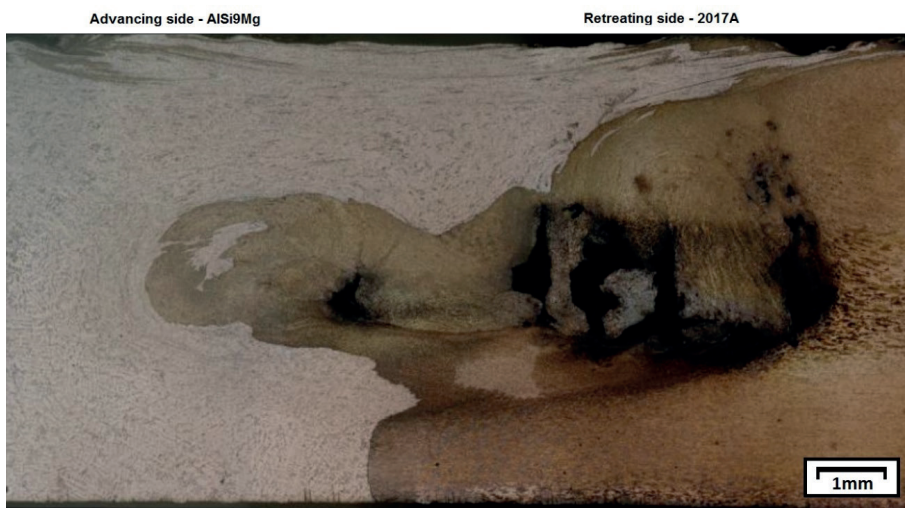
*Fig. 1. Single macrostructure cross section of AISi9Mg/2017A weld (within range including center of weld portion)*

Our studies on the structures of the FSW welds started from an analysis of the macrostructure of the conventional method: by performing a cross-section perpendicular to the face of the weld and performing metallographic observations. An image of a single macrostructure cross section of the weld (within a range that included the center of the weld portion) is shown in Figure 1. A detailed analysis was made possible by obtaining an image macro (the entire weld) on the basis of 96 microscopic images made with a light microscope. A weld made in the system (the AlSi9Mg aluminum alloy) is located at the advancing side (left side of Figure 1) and, accordingly, the 2017A alloy on the retreating side.

On the basis of the microstructure, it can be seen that there is the disadvantage of a complex shape of the central portion of the weld in the analyzed cross-section. The defect is located in the middle of the weld and (mostly) on the retreating side – in the alloy with a higher strength at room temperature (i.e., 2017A). The place where the defect is observed is often identified as critical for FSW welds; this is related to the flow of material as a result of the movement of the FSW tool – the material is moved around the tool and

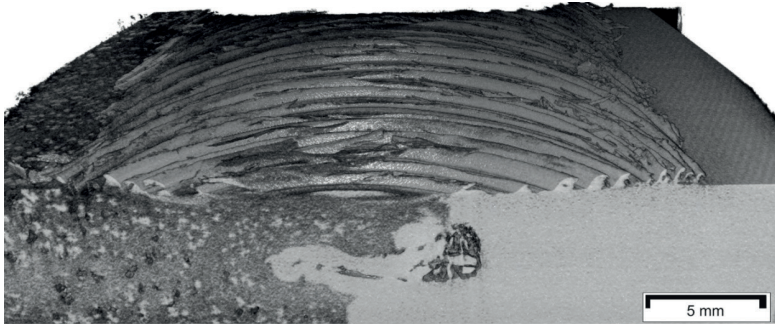
*Fig. 2. Three-dimensional model of AlSi9Mg/2017A weld*

Figure 2 shows a three-dimensional model of the sample. Due to the difference in the density of the structural components present in the material forming the weld, there is a clear difference between the AISi9Mg and 2017A alloys. Due to the higher content of Cu and Fe having a high coefficient of density, the 2017A material assumes lighter shades

of gray. In turn, the cast alloy (AlSi9Mg) shows shrinkage porosity that is clearly marked; this arises in the process of casting the material and the segregation of elements.

Clearly visible grooves on the face of the weld are formed after the passage of the shoulder of the FSW tool. The tool mixing the material from the retreating side to the advancing side. Thus, the use of microtomography allows us to observe the external surface of the weld.

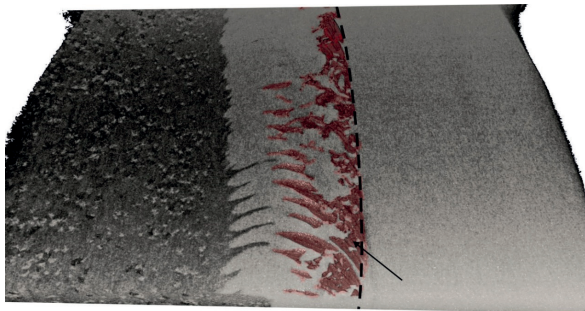
*Fig. 3. One analyzed plane – three-dimensional model of sample “virtually cut” at distance of about 3 mm from face of weld to present geometry of defects in whole length of direction of linear motion of tool*

The primary advantage of computer microtomography, however, is the non-invasive observation of the internal structure of the tested material on any chosen plane. One of the analyzed planes is shown in Figure 3. A three-dimensional model of a sample that is “virtually cut” at a distance of about 3 mm from the face of the weld is used to present the geometry of the defects in the whole length of the direction of the linear motion of the tool.

The observation revealed that the defect (indicated by the arrow in Figure 3) is a tunnel that occurs at the retreating side. The tunnel is located along the plane (the border of the direct action of the pin-tool) designated by the movement of the tool.

The edge of the plane is indicated by the dashed line in Figure 3. The shape of the tunnel varies with the linear movement of the tool, which demonstrates the changing conditions while welding. Furthermore, it can be seen that the defect extends to the weld axis in some areas [17]. As stated in this type of tunnel, defects can be formed as a result of the more rapid movement of the material flow near the face of the weld relative to the lower layers in the weld. Using this form of analysis, we can determine the location of the welding materials in the weld. Figure 3 clearly shows a boundary between the AlSi9Mg material (advancing side) and a section of the weld nugget, which are usually in the FSW joints made of the alloy originating from the retreating side – in this case, it is the 2017A alloy.

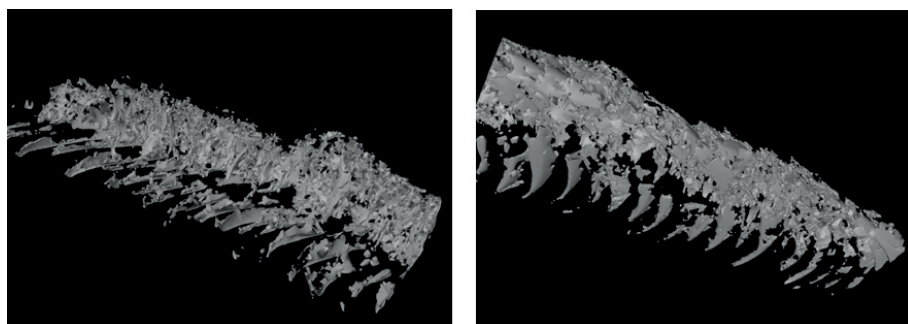
Fig. 5. Extraction of defect from 3D image

Features of X-ray projections allow for further modifications and obtaining images that show only the extracted objects in the three-dimensional image. Such objects are obtained by means of morphological operations performed on the 3D model in the Drishti program. An example of this technique of analysis for test defects is shown in Figure 4. As can be seen in this figure and Figure 5, this is possible to analyze a smaller area of the sample, in addition to obtaining a more precise 3D model of the defect, which in practice means observations at higher magnifications. This is possible thanks to the high resolution scan of the tested sample. Using the characteristics of the image obtained, it was found that the defect (except the tunnel characters) extends towards the axis of the weld in the form of an arc. Because the microtomography research is done in the scale, there are possible distance measurements in the pictures. Using this function, the distances between the arches were measured – these results are summarized in Table 2.

The distance measurement results show that the defect passes in the form of an arc at about 1 mm. Comparing this value with the parameters of the tool movement, it can be seen that it is formed by one rotation of the tool. When there is a linear velocity of 560 mm/min and a rotation rate of 560 rpm, the tool performs one rotation during a linear displacement of about 1 mm.
